Castro Valley Elementary, Castro Valley Safe Routes to Schools Site Assessment Recommendations

Site Assessment Held May 2016

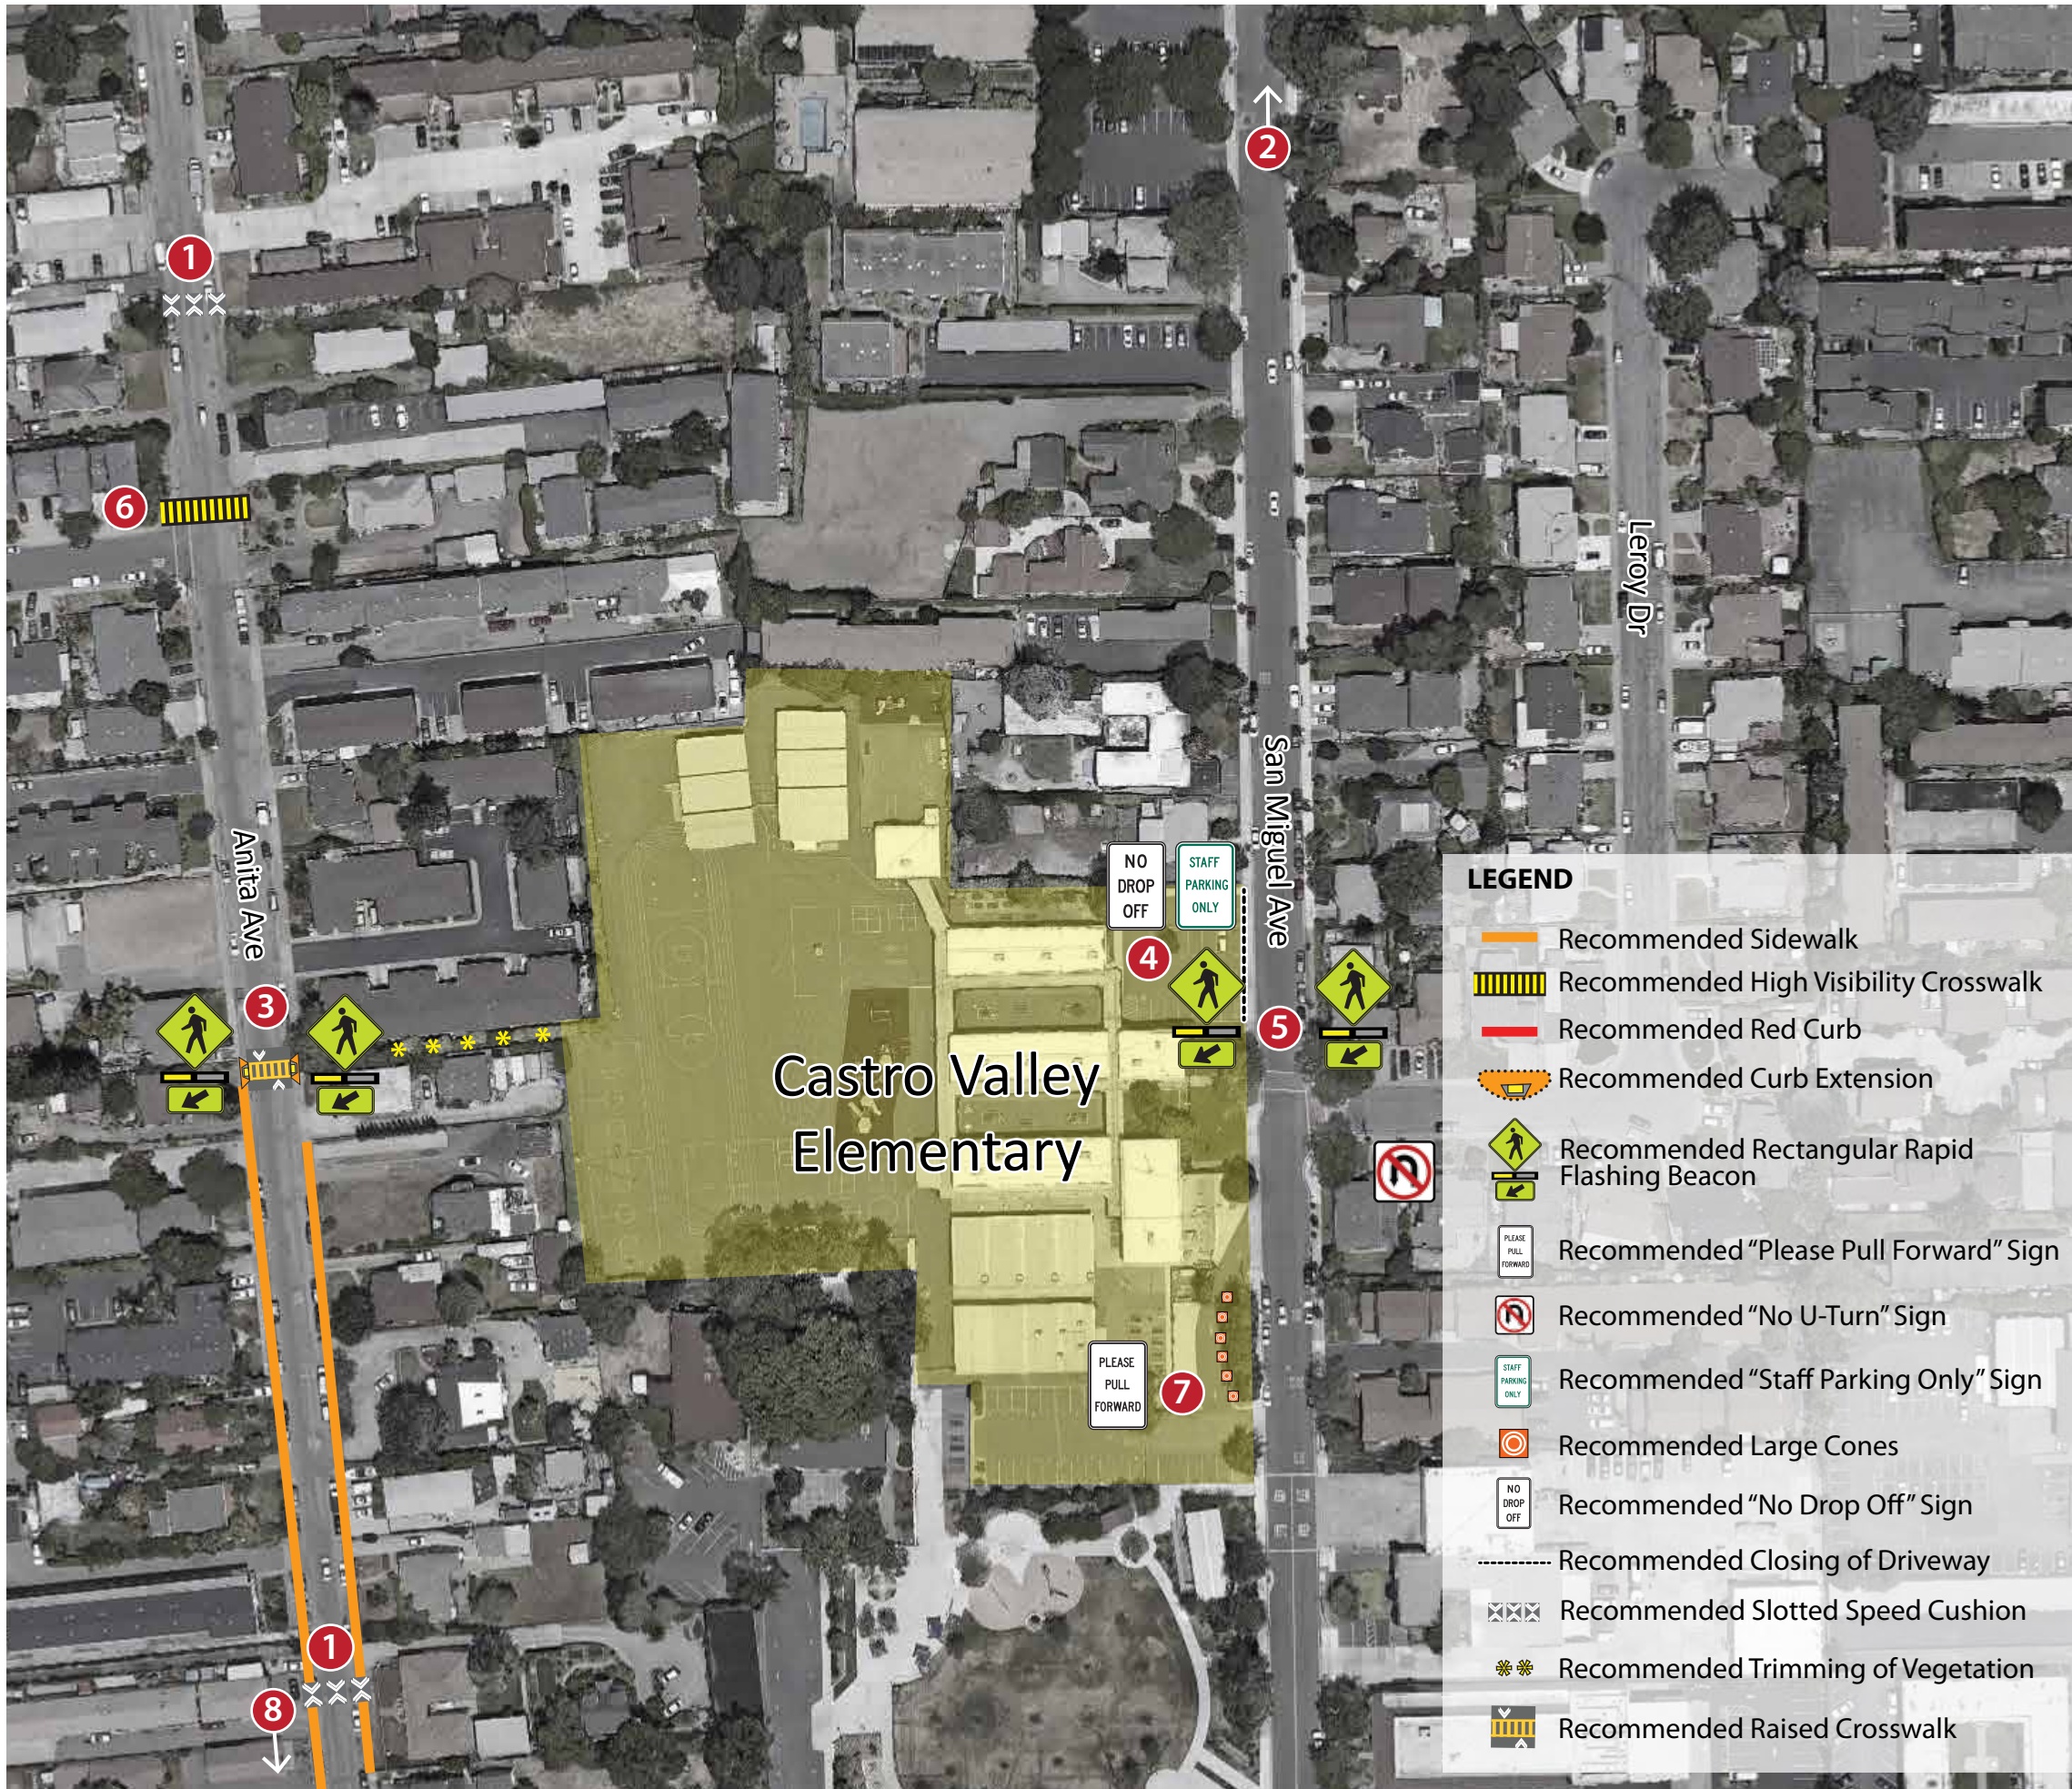
- Anita Ave (Alameda County Public Works Agency (ACPWA))**
-Slotted speed cushions.
-Sidewalks where needed to close gaps (in design). In the short-term, consider striping white edge line to delineate pedestrian space.

- San Miguel Ave (ACPWA/Castro Valley Unified School District (CVUSD))**
-Red curb at edges of Our Lady of Grace driveway to increase pedestrian visibility.

- Anita Ave (ACPWA/CVUSD)**
-Curb ramps and curb extensions (in design).
-Raised midblock crosswalk (in design).
-Rapid Rectangular Flashing Beacons (RRFB) (in design).
-Pedestrian-scale lighting on path to school campus (CVUSD).
-Trimming vegetation that encroaches on path (CVUSD).

- North Parking Lot (CVUSD)**
-"Staff Parking Only" sign.
-"No Drop Off" sign.
-Closing off driveway in the morning after staff have arrived.
- San Miguel Ave (ACPWA)**
-Diagonal down arrow on RRFB assembly on west side of crosswalk.
-Beacon between signs to match typical RRFB configuration
-Advanced yield lines.

- Anita Ave/Witcher St (ACPWA)**
-High-visibility crosswalk.
- Drop-off Zone (CVUSD)**
-"Pull Forward" sign at end of drop-off zone.
-Larger cones to replace existing smaller ones.

- Anita Ave (ACPWA)**
-Missing sidewalk and pedestrian facilities south to Castro Valley Blvd (in design). In the short-term, consider striping white edge line to delineate pedestrian space.
The above items are recommendations only and based on Safe Routes to Schools site assessments best practices. Feasibility determination, final design, funding, and implementation of any recommended improvements is the responsibility of the appropriate governing agencies.
