# School Safety Assessment Technical Memorandum

Dougherty Elementary School

Dublin Unified School District

January 2018

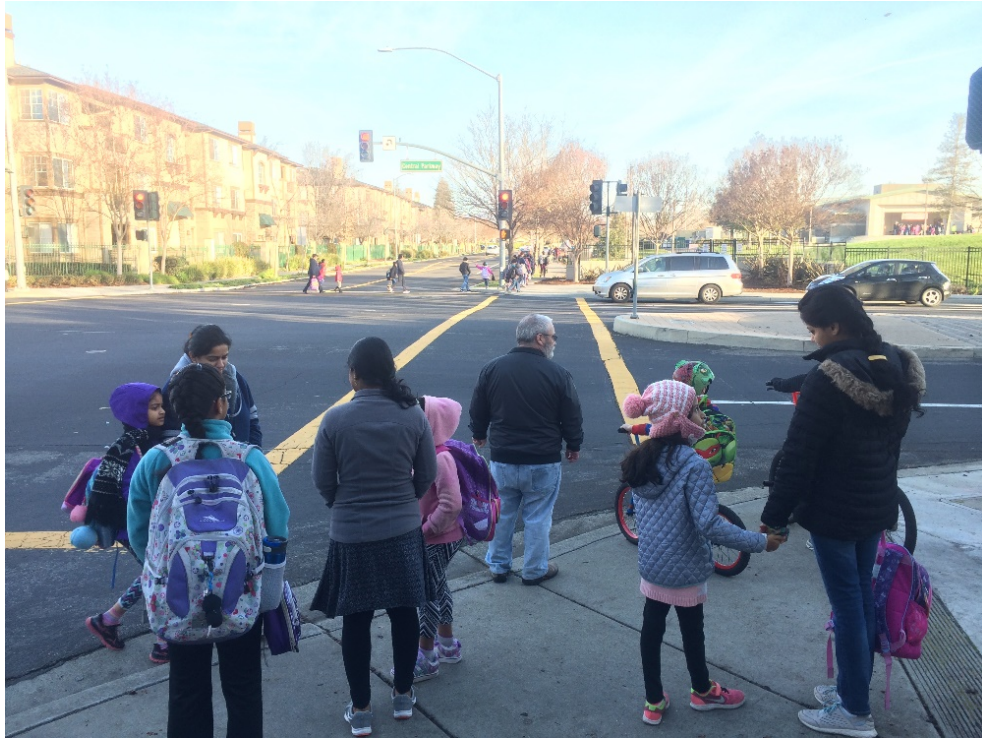
*Children crossing with parents across Central Parkway at Hibernia Drive*

- ◆ At Hibernia Drive and Central Parkway there is an existing traffic signal. The crossing of Central Parkway is approximately 90 feet across, and the team observed some pedestrians having difficulty making it all the way across before the countdown completed due to not having enough time.

- ◆ Central Parkway has a center planted median, but it does not extend all the way to the crosswalks to provide a pedestrian refuge function.
- ◆ The highest vehicle speeds visually observed during the site assessment were traveling northbound on Hibernia Drive and eastbound along Central Parkway.

- Extend median to provide pedestrian refuge island at Hibernia Drive
  - Evaluate crosswalk signal timing to allow additional time for pedestrians as well as Leading Pedestrian Interval to cross at Hibernia intersection
- 2
- Aspen Street and Central Parkway**

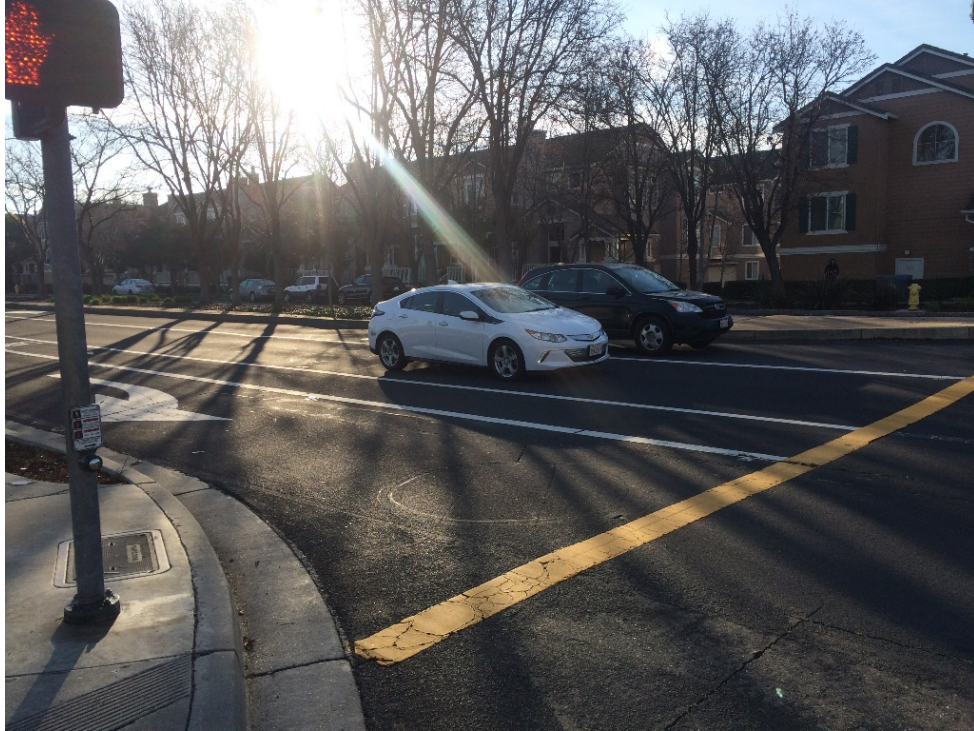
*Vehicles were observed turning right quickly off of Central Parkway westbound onto Hibernia Drive northbound*

- ◆ The team observed motorists taking high speed right turns from westbound Central Parkway onto Hibernia Drive northbound; wider corner radius may have contributed to these higher speed turn movements.
