School Safety Assessment Technical Memorandum

Corvallis Elementary School

San Lorenzo Unified School District

April 2018

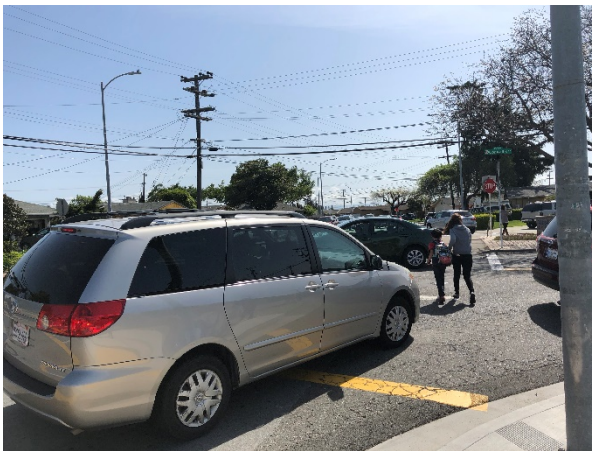
- ◆ Participants noted that cars regularly block the southwest corner while queuing at the intersection for the drop-off loop.

Left: A van blocks the crosswalk across Farnsworth Street as a family crosses Corvallis Street

- Install 20 feet of red curb around every intersection departure corner and 10 feet at approach corners. Evaluate each corner for exact red curb length

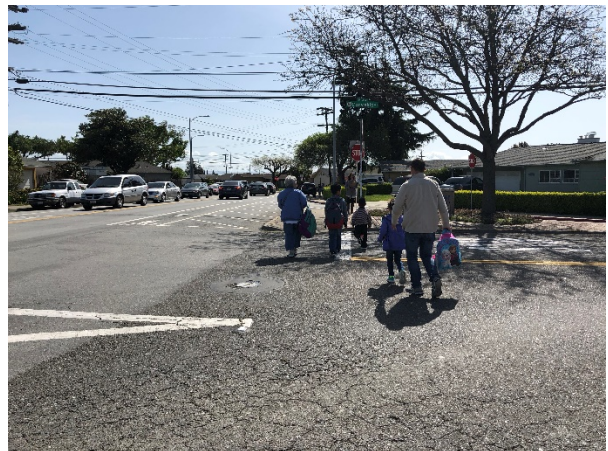
- ◆ Pedestrians were observed crossing Farnsworth Street in the crosswalk, and crossing Corvallis Street, north of the triangular island (unmarked crosswalk).

- Over 70 students and families were observed crossing Corvallis Street at this location.
 - Assessment participants expressed concern about the unmarked crossing, especially given the sometimes-unpredictable turning movements (described below) from both directions on Farnsworth Street.

Right: A group of students and families crossing Corvallis Street

- Upgrade the existing transverse crosswalk at the east approach to a high visibility crosswalk. Install R1-6 crosswalk yield paddle sign
 - Install a high visibility crosswalk across the northern approach

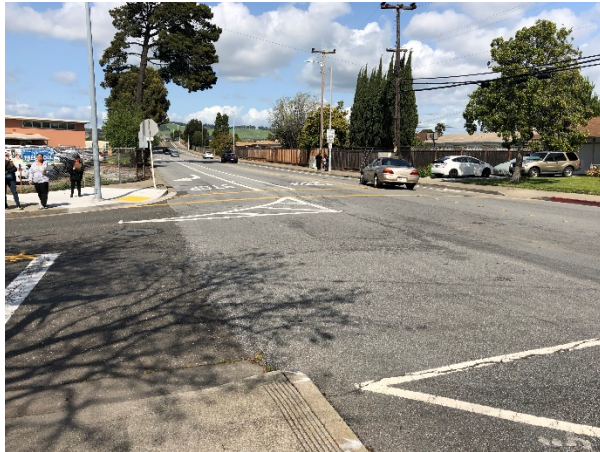
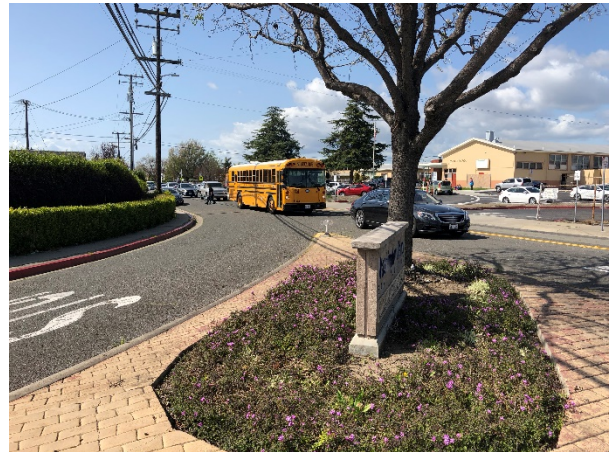
- ◆ Corvallis Street/Farnsworth Street is a T-intersection. The southbound right turn is facilitated via a free right turn lane (slip lane). The raised triangular island is landscaped.

Left: The Corvallis Street/Farnsworth Street intersection looking east from the triangular island
Right: Looking at Corvallis Street and the school from the triangular island

- 1 Corvallis Street/Farnsworth Street**
- Remove the southbound free right turn lane. Build out the northwest corner to square up the intersection. Create a two-lane approach with a left turn lane and a right turn lane

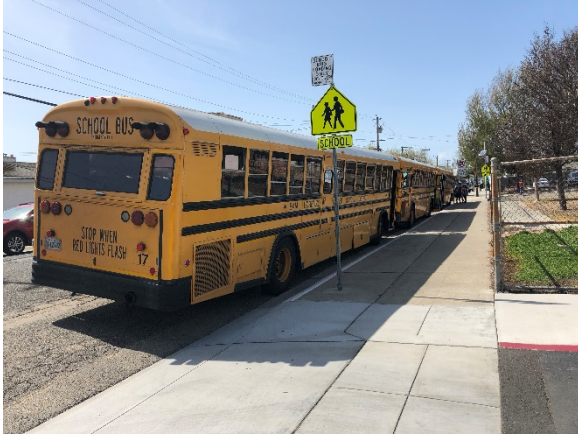
- ◆ On Corvallis Street there is a white curb area, between two loop driveways, where three large school buses stage to load/unload students.
 - This space is not long enough to store three 40-foot buses and allow for sufficient visibility for cars approaching and exiting the driveways.

- The buses will sometimes extend into the red curb or partially block the driveway.
- ◆ Multiple pedestrians were observed crossing Corvallis Street at Brown Court. There are no marked crossings at this location.

Left: Three large buses parked on Corvallis Street. The rear bus overhangs into the driveway

- Convert the existing white curb space on the east side of Corvallis Street from a bus zone to a drop off zone
 - Install accompanying R25D School Zone loading signs

- Reconfigure the drop-off loop and parking lots to serve San Lorenzo Unified buses. Prohibit families from driving into the drop-off loop
 - Consolidate down to one entry driveway and reconfigure the parking stalls to create 170 feet of bus loading space (maintaining the ADA zone on the north side of the loop)

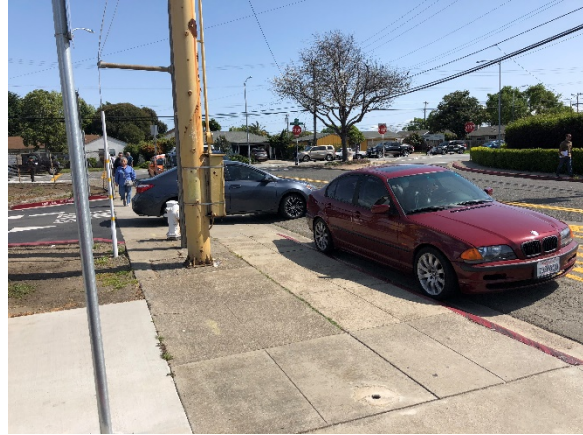
Right: One of the cars that parked too close to driveways to allow for sufficient visibility

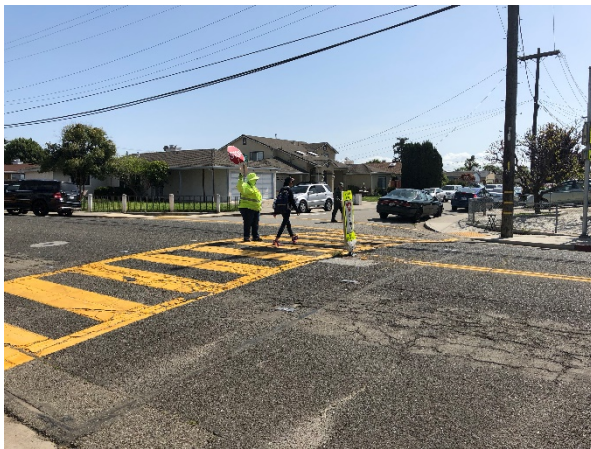
- ◆ There is an existing yellow high visibility crosswalk across Corvallis Street at the northern approach to the Oberlin Avenue intersection.
 - A crossing guard is stationed at this intersection.

- The crossing guard noted that sometimes cars will not comply with her stop/yield commands. She said that sometimes this is due to distracted driving.

Bottom Left: The crossing guard crossing a student across Corvallis Street at Oberlin Avenue

- Relocate the existing crossing guard from the Corvallis Street/Oberlin Avenue intersection to the new midblock crossing
 - Remove the existing marked crosswalk from the northern approach to the Corvallis Street/Oberlin Avenue intersection (replaced with above midblock)

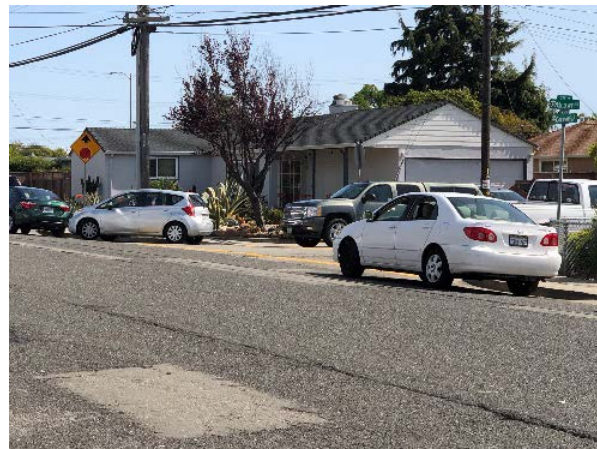
Bottom Right: A car blocking a curb ramp at the Corvallis Street/Brown Court intersection

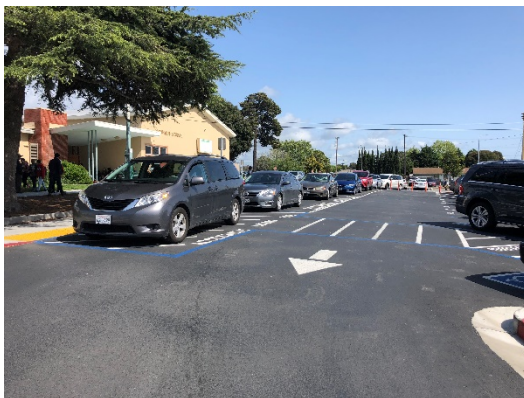
- ◆ Corvallis Elementary school has one drop-off loop (with some parking) and three small parking lots, one of which is only accessible through the drop-off loop area.

- ◆ Driveways from north to south: Staff parking lot, drop-off loop/parking lot, and staff parking lot.
- ◆ The drop-off loop area is the center of activity during pick-up and drop-off times.

Left: The drop-off loop, looking towards the entrance

- Paint the curb along the drop-off area yellow and install R25F School Bus Loading Signage

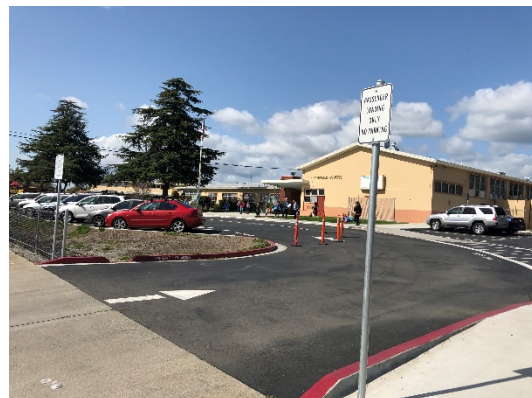
- ◆ As noted above, cars will back up and queue on Farnsworth Street, in both directions, waiting to enter the drop-off loop.
 - To the east, the queue will reach halfway to I-880.

Right: The entrance of the drop-off loop
