**RE: School Safety Assessment at Elmhurst United Middle**

# School Safety Assessment Technical Memorandum

Elmhurst United Middle School

February 2020

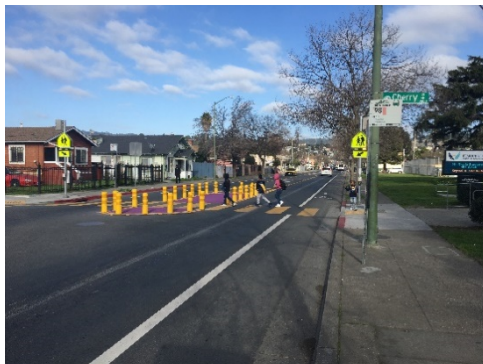
- ◆ There is a high-visibility crosswalk on the eastern approach of this intersection with a rectangular rapid flash beacon (RRFB). There is a transverse crosswalk on the northern approach of this intersection across Cherry Street.

- ◆ SSA participants observed a high volume of students crossing through the eastern and northern approaches of the intersection.
- ◆ SSA participants observed vehicles driving in the center turn lane on 98<sup>th</sup> Avenue in order to bypass vehicles queued at the light or waiting to turn right and reach intersection turn lanes. Participants noted that use of the center turn lane as a bypass lane is a common occurrence, and that vehicles doing this will speed up the center lane to bypass a queue and then merge back into the travel lane in a reckless manner.

*Left: Students walk through the crosswalk across 98<sup>th</sup> Avenue.*

**Cherry Street/98th Avenue**  
2. After the School Safety Assessment, this intersection received many infrastructure improvements including a concrete median and RRFB through OakDOT's Rapid Response Program.
- 3

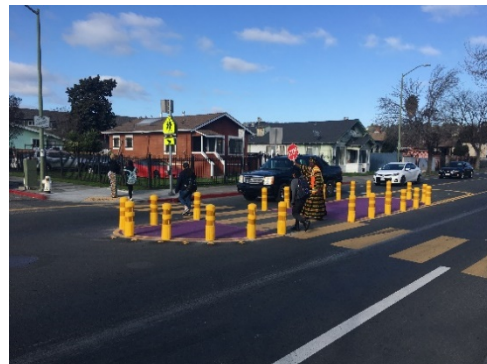
- ◆ A school staff person volunteers as a crossing guard to help students and families cross 98<sup>th</sup> Avenue at this location; however, it is common for vehicle traffic to not stop or yield to the crossing guard and pedestrians using the crosswalk.

- ◆ Advance yield pavement markings are painted on 98<sup>th</sup> Avenue approaching the crosswalk. SSA participants mention that vehicles regularly disregard the advance yield pavement markings at this location and stop closer to the crosswalk.

*Right: The volunteer crossing guard accompanies students across the street. Vehicles have stopped after the advance yield pavement markings on 98<sup>th</sup> Avenue.*

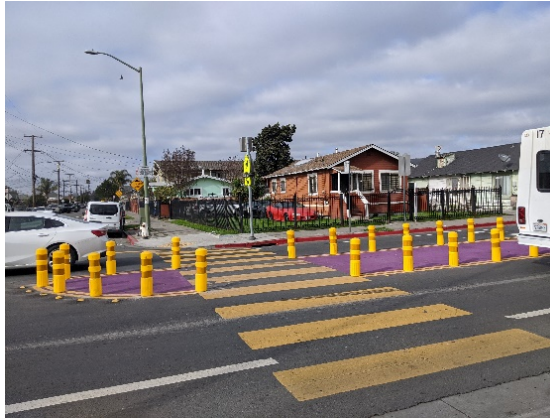
- ◆ In late January 2020, OakDOT installed a paint and post median refuge island on the eastern approach of the crosswalk.
- ◆ There are AC Transit stops on 98<sup>th</sup> Avenue upstream of the crosswalk in both directions. Buses pulling to the curb block the bike lane and partially block the travel lane. Bus loading reduces visibility of students entering the crosswalk for vehicles behind, and also results in impatient drivers swinging into the center turn lane to bypass the bus on the left.

*Above: The paint and post median refuge island installed in the 98<sup>th</sup> Avenue median.*

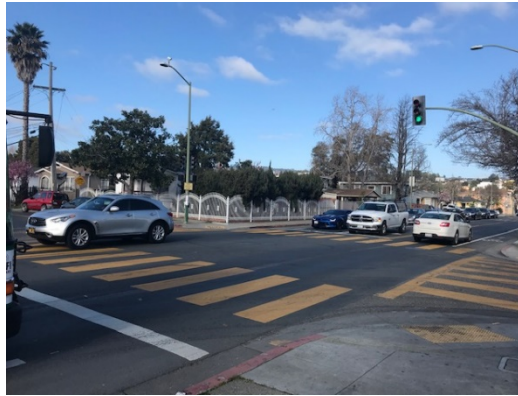
- ◆ SSA participants observed a high volume of students traveling north and east through the intersection as they left school.
- ◆ Substantial traffic queuing occurs on southbound Birch Street right near the intersection of 98<sup>th</sup> Avenue, causing congestion to back up onto 98<sup>th</sup> Avenue for vehicles attempting to turn onto Birch Street. SSA participants watched vehicles use the center turn lane to bypass traffic queues along 98<sup>th</sup> Avenue, and travel into the opposing travel lane on Birch Street to bypass vehicles.

- ◆ In the northbound direction on Birch Street, queuing occurs as vehicles wait at the signal to turn left or right onto 98<sup>th</sup> Avenue. The length of the signal cycle is not sufficient to clear the number of vehicles trying to exit from Birch Street during peak school pick-up.

- ◆ There is fading red curb at all corners of the intersection.

*Above: Vehicles travel through the intersection of Birch Street at 98<sup>th</sup> Avenue.*

**Birch Street/98th Avenue**  
3a. Install hardened centerline on all intersection approaches  
3b. Refresh red curb to daylight intersection\*\*  
3c. Study signal timing to increase rate of clearing cars queued on Birch Street during pick-up hours
- 4

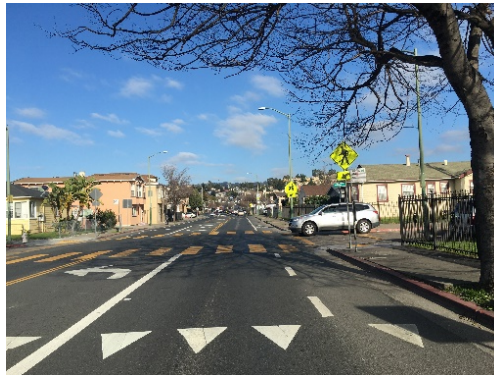
- ◆ The intersection of Olive Street and 98<sup>th</sup> Avenue is stop-controlled on Olive Street.
- ◆ There are two existing high visibility crosswalks across 98<sup>th</sup> Avenue. There are two existing transverse crosswalks across Olive Street.
- ◆ SSA participants watched vehicles use the center turn lane to bypass traffic queues along 98<sup>th</sup> Avenue. Impatient drivers turning left entered the center turn lane and used it as a travel lane to reach the turning queue.
- ◆ SSA participants noted that the red curb is fading at the corners of the intersection.
- ◆ SSA participants reported that vegetation on the southwest corner of the intersection obstructs the visibility of existing School Assembly B signage.

*Left: The intersection of Olive Street at 98<sup>th</sup> Avenue*

**Olive Street/98th Avenue**  
4a. Install hardened centerline on all intersection approaches  
4b. Upgrade north and south crosswalks to high visibility  
4c. Refresh red curb to daylight intersection\*\*  
4d. Trim vegetation to improve visibility of existing signage
- 5

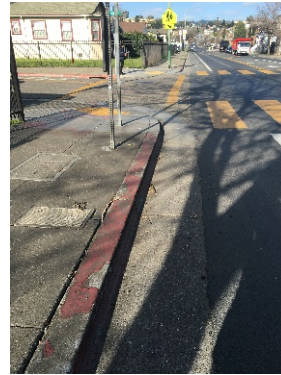
*Right: Fading red curb at the intersection.*

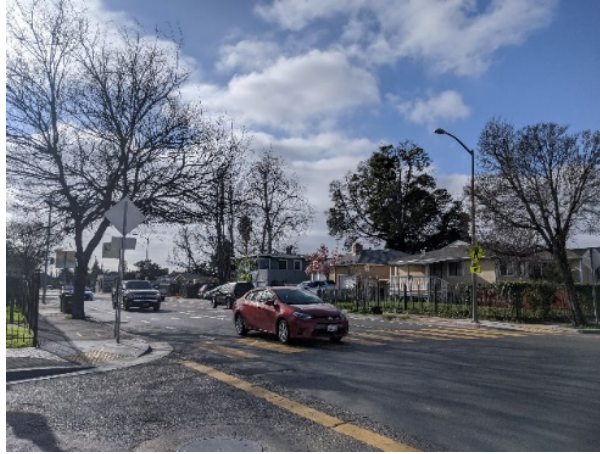
- ◆ The intersection of Plymouth Street and 98<sup>th</sup> Avenue is a four-way signalized intersection.
- ◆ SSA participants observed vehicles entering the center turn lane to bypass vehicles queued at a light ahead in order to reach the turning lane at the intersection.
- ◆ SSA participants said that northbound vehicle traffic on 98<sup>th</sup> Avenue backs up at this intersection during the school dismissal period. SSA participants observed conflicts between turning vehicles and pedestrians crossing Plymouth Street due to high volumes of pedestrian traffic and impatient drivers.
- ◆ There is existing, fading red curb around all four corners of the intersection.
- ◆ A 'Speed Limit 30' sign is posted on southbound 98<sup>th</sup> Avenue past Plymouth Street.
- ◆ A bicycle detection loop is painted on Plymouth Street at the intersection of 98<sup>th</sup> Avenue.

*Above: A vehicle travels through the intersection of Plymouth Street and 98<sup>th</sup> Avenue.*

**Plymouth Street/98th Avenue**  
1a. Install hardened centerline on all approaches  
1b. Refresh red curb to daylight intersection\*\*  
1c. Install new bus shelter and seating at relocated transit stop.
- 2

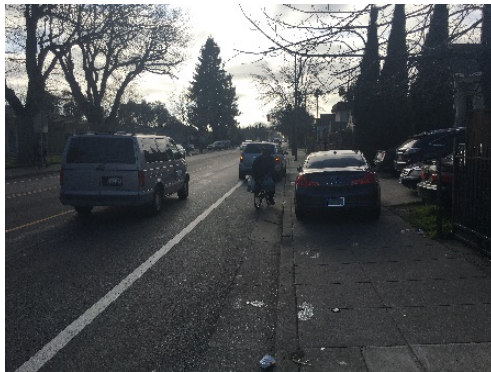
- ◆ SSA participants observed vehicles stopping along 98<sup>th</sup> Avenue to drop students off in front of the school, blocking both the bike lane and the bus stop.
- ◆ SSA participants observed vehicles speeding along 98<sup>th</sup> Avenue.
- ◆ During the SSA the sidewalk on 98<sup>th</sup> Avenue opposite the school was blocked by a parked vehicle in one of the residential driveways; it is not known if this is a regular occurrence.

*Left: A vehicle stops in the bike lane along 98<sup>th</sup> Avenue.*

**98th Avenue - School Frontage**  
5a. Install red curb along school frontage  
5b. Install SR4-1 "School Speed Limit Assembly C" signage along 98th  
5c. Consider relocating existing bus stop west of Plymouth St
- 6

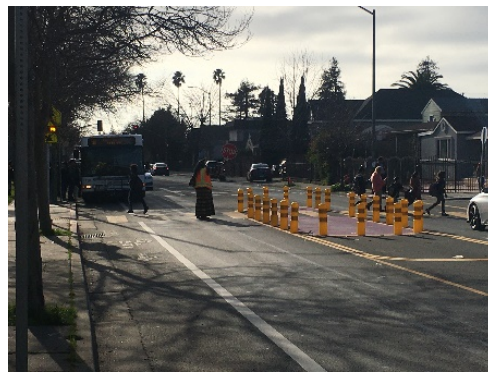
*Right: An AC Transit bus stops along the 98<sup>th</sup> Avenue school frontage.*

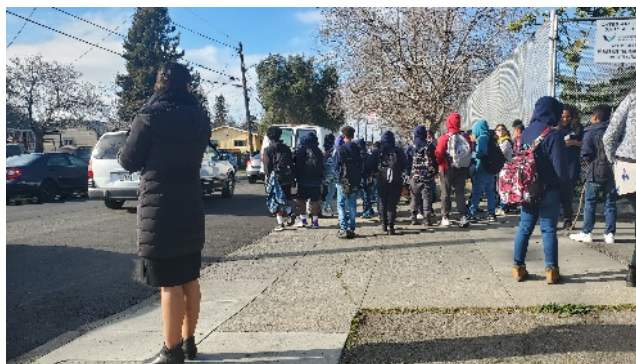
- ◆ SSA participants observed high volumes of students leaving campus and traveling north and south along Plymouth Street.
- ◆ SSA participants said that many students are picked up in private vehicles on Plymouth Street.

*Above: Students exit school onto Plymouth Street.*

**Plymouth Street - School Frontage**  
6a. Install red curb and R24A "School Bus Only" signage south of school driveway  
6b. Install white curb and R25D "School Loading Zone" signage along remainder of school frontage toward 99th Avenue
- 7

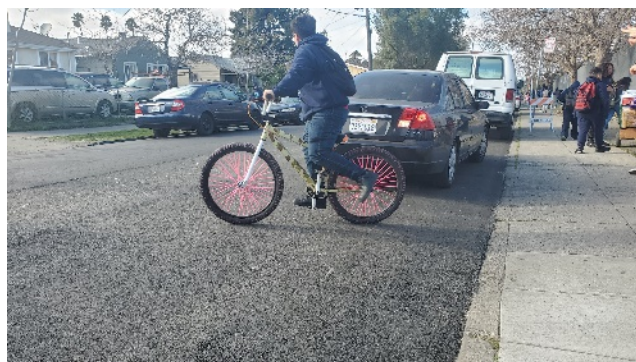
*Above: A student on a bicycle enters Plymouth Street. Their visibility is limited by stopped vehicles along the school frontage.*

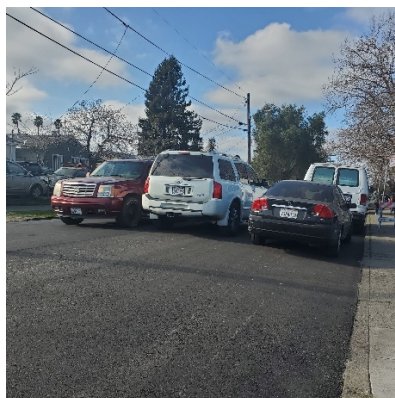
- ◆ SSA participants said that there is no dedicated space for the Elmhurst United school bus. Parked and stopped vehicles prevented the school bus from picking students up near the school entrance.
- ◆ SSA participants observed vehicles double parked on both sides of the street, which limited travel lane widths and created conflicts between drivers traveling in both directions along Plymouth Street.

*Above: Vehicles navigate narrow road space between two sides of parked or stopped vehicles along Plymouth Street.*

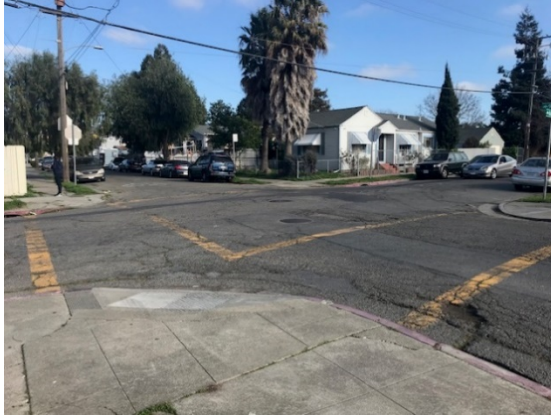
- ◆ The intersection of Birch Street and 99<sup>th</sup> Avenue is stop-controlled on all approaches. There are four faded transverse crosswalks at the intersection of Birch Street and 99<sup>th</sup> Avenue.
- ◆ SSA participants observed students traveling this intersection as they walked home from school.
- ◆ There are not school assembly signs on Birch Street approaching the school.
- ◆ The red curb around the corners of the intersection is fading.
- ◆ SSA participants observed high volumes of students leaving campus and traveling north and south along Birch Street.
- ◆ SSA participants said that many students are picked up in private vehicles on Birch Street.
- ◆ SSA participants observed vehicles parked on both sides of the street limiting travel lane widths. This created conflicts between vehicles traveling in both directions on the street.

*Above: Fading crosswalks and red curb.*

**Birch Street/99th Avenue**  
10a. Install paint and post curb extensions on all corners  
10b. Install high visibility crosswalks and advance stop pavement markings on all legs of intersection  
10c. Install "School Assembly B" signage on northbound approach  
10d. Refresh fading red curb to daylight intersection\*\*
- 11

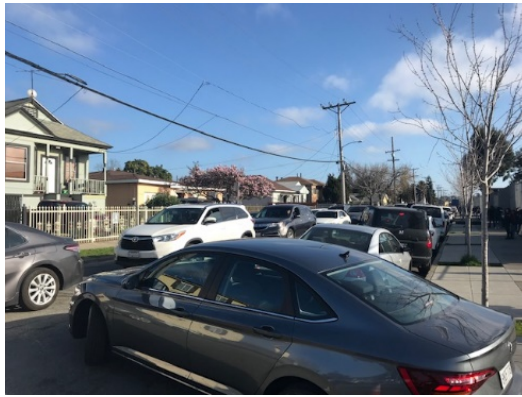
*Left: Vehicle congestion and conflict as drivers navigate space between parked or stopped vehicles on both sides of the street.*

**Birch Street - School Frontage**  
11a. Install white curb and R25D "School Loading Zone" signage along school frontage from 98th Ave to Warner Ave

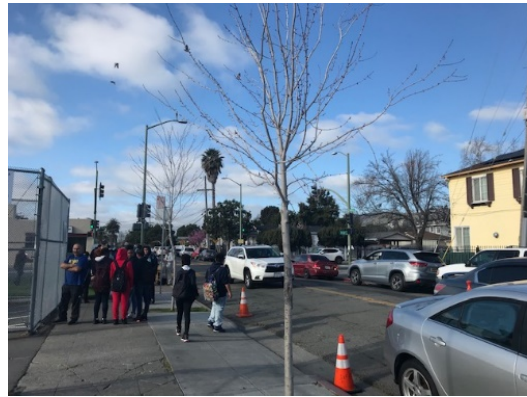
*Right: Students exit campus and travel along Birch Street.*

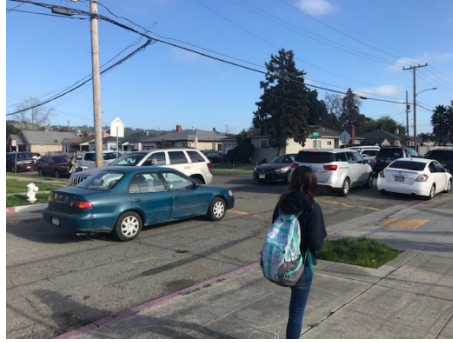
- ◆ The intersection of Birch Street and Warner Avenue is uncontrolled. There are two faded transverse crosswalks on the northern and eastern approaches of the intersection.
- ◆ SSA participants observed northbound traffic backing up through the intersection and blocking traffic.
- ◆ SSA participants observed vehicles parked within the intersection which obstructed the visibility of people in the crosswalk. Vehicles also backed up into the intersection due to congestion at the intersection of Birch Street and 98<sup>th</sup> Avenue and near the school exit.
- ◆ SSA participants saw students cross through the unmarked southern approach of the crosswalk.

*Left: A student travels down Birch Street toward the intersection. Stopped vehicles are blocking the crosswalk.*

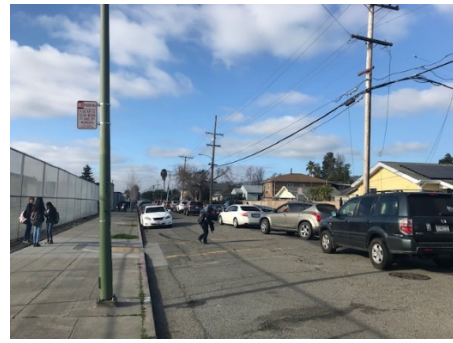
*Right: Students exit campus and travel along Birch Street.*
