School Safety Assessment Technical Memorandum

CRAGMONT ELEMENTARY SCHOOL

830 Regal Rd, Berkeley, CA 94708

October 2022

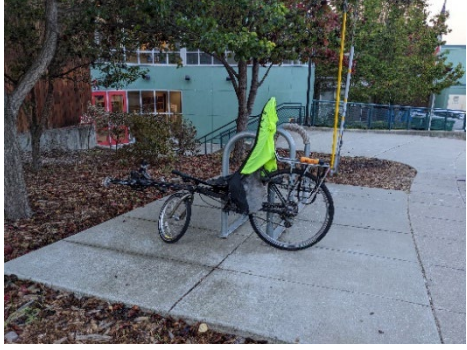
<p>There are three U-racks outside of the main office along the southern sidewalk of Regal Rd with capacity for six bikes.</p> <p>Typically, there are only three or fewer bicycles using the rack outside the school, though several parents were observed dropping students off with their own longtail bikes.</p>
<p>How do school buses interact with the school?</p>

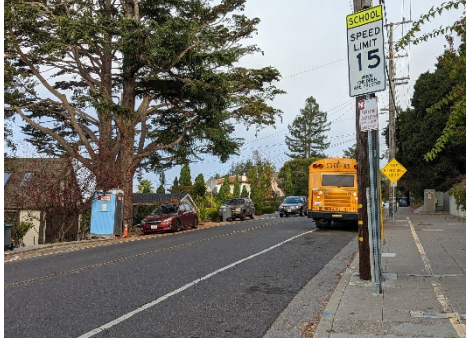
<p>School buses drop off and pick up students from the eastern sidewalk on Spruce St, north of the intersection with Marin Ave.</p>

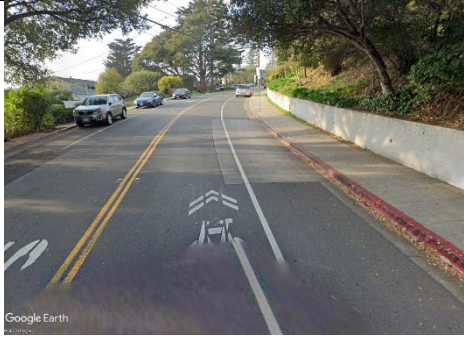
AC Transit Route 67, on Spruce St, has stops at the northeast and southwest corners of the intersection with Marin Ave (NE stop adjacent to school pictured).
Does the school have special pick-up/drop-off policies/procedures?

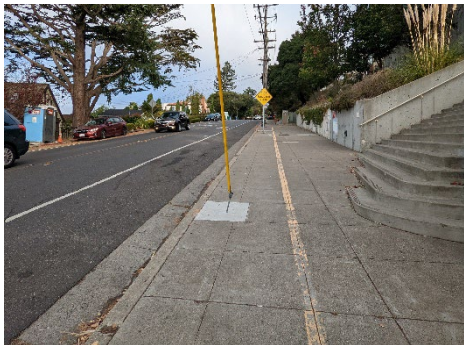
There are three school access points: Spruce St, Regal Rd, and Marin Ave. Although all are available during pick-up and drop-off, the school recommends using the Spruce St entrance for safety reasons, where a staff person waits in the morning to greet students as they arrive. This is also where school buses park.

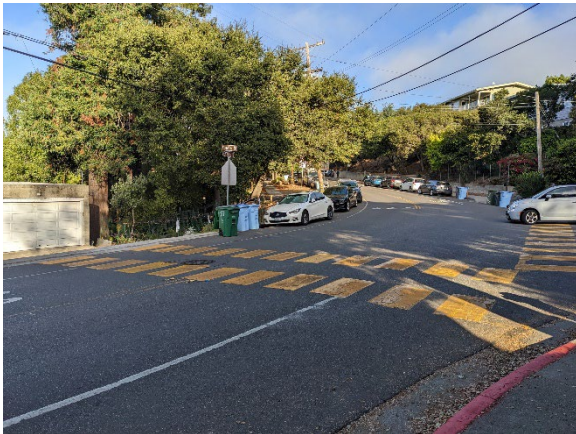
- ◆ The T-intersection of Regal Rd at Spruce St is stop-controlled on the Regal Rd approach and has marked crosswalks on the southern and eastern legs.
- ◆ At the intersection, Spruce St curves away from Regal Rd on an incline, going downhill as one travels southbound.
- ◆ Bicycles were observed traveling in both directions.
- ◆ Southbound drivers on Spruce St have a blind, downhill turn as they approach the crosswalk at Regal Rd.
 - Participants observed drivers crossing the double yellow centerline to pass stopped garbage and delivery trucks around this blind turn, with limited sightlines to the crosswalk across Spruce St.
 - The crosswalk across Spruce St ends in a driveway on the western side of the street.
- ◆ The large curb radii and width of the Regal Rd approach allow for faster vehicle turns and make it easier to block crosswalks at the corners.

Left: Crosswalk across Spruce Street at Regal Rd looking uphill (north) at the blind turn.

- *Study options across Spruce St for crosswalk relocation. Consider sightlines, elevation, and driveway access to determine what is the safest, but also more accessible location. Crosswalk relocation may include the construction of curb ramps, red curb, signage, pavement markings, and street lighting for the new crosswalk. Multiple components of potential crosswalk relocation are subject to traffic engineer review and residential outreach.*

- *Consider conducting a warrant study for all-way stop control.*

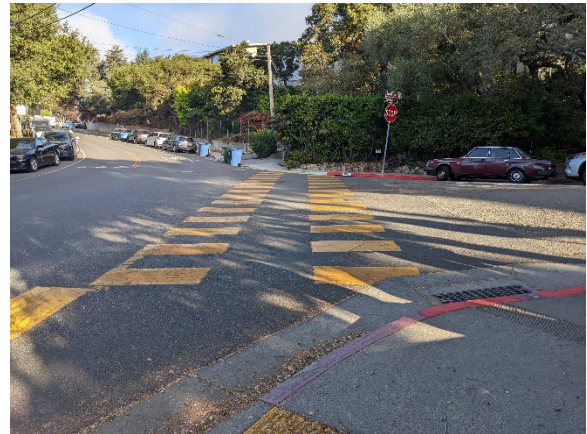
Right: Crosswalk across Regal Rd at Spruce St is extremely long (65 feet) and without protection for pedestrians.

- *Short term, consider constructing a paint and post curb extension on Regal Rd on the northeast corner of the intersection with Spruce St. Long term, consider upgrading paint and post to concrete curb extension, with attention to concerns about existing stormwater drainage infrastructure, adjacent driveways, and potential crosswalk relocation in the design. Outreach to residents will be necessary due to the potential impacts on residential parking.*

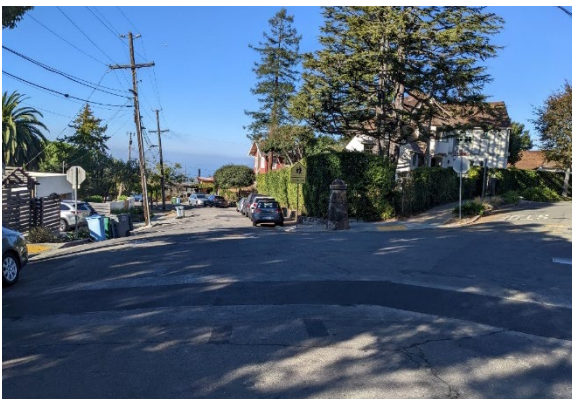
- ◆ Regal Rd at Cragmont Ave is stop-controlled on all four approaches, and has marked crosswalks on the northern, western, and southern legs. Both roads have one travel lane in each direction with on-street parking.
 - This is an offset, angled intersection with wide approaches at non-right angles.
 - The southern curb of the western leg of Regal Rd is red curb.
- ◆ Drivers traveling east on Regal Rd were seen entering the intersection without stopping at the stop sign.
- ◆ Drivers parked along red curb zone or double parked on Regal Rd to drop off their students.
- ◆ A walking school bus crossed at this intersection.

Left: Wide intersection geometry looking west toward Regal Rd. Some drivers failed to comply with stop sign on the left.

- *Consider squaring the offset intersection by constructing curb extensions on the southwestern corner where the southern leg of Cragmont Ave intersects with Regal Rd, and on the northeastern side of Regal Rd where it intersects with the northern leg of Cragmont Ave. Further engineering design and residential outreach will be necessary prior to implementation.*
- *Restripe existing high-visibility crosswalks (northern, western, and southern legs) as triple-fours, and stop bars at all legs (requires verification of sight lines by the city traffic engineer).*
- *Extend red curb 35 ft on the south side of Regal Rd, from Cragmont Ave to the crosswalk west of Cragmont Ave (requires sight line verifications from the city traffic engineer). Residential outreach will also be necessary prior to implementation.*

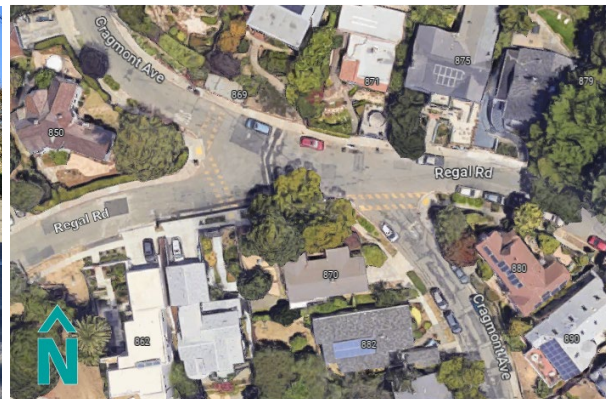
Right: Aerial map of the intersection geometry of Cragmont Ave and Regal Rd.

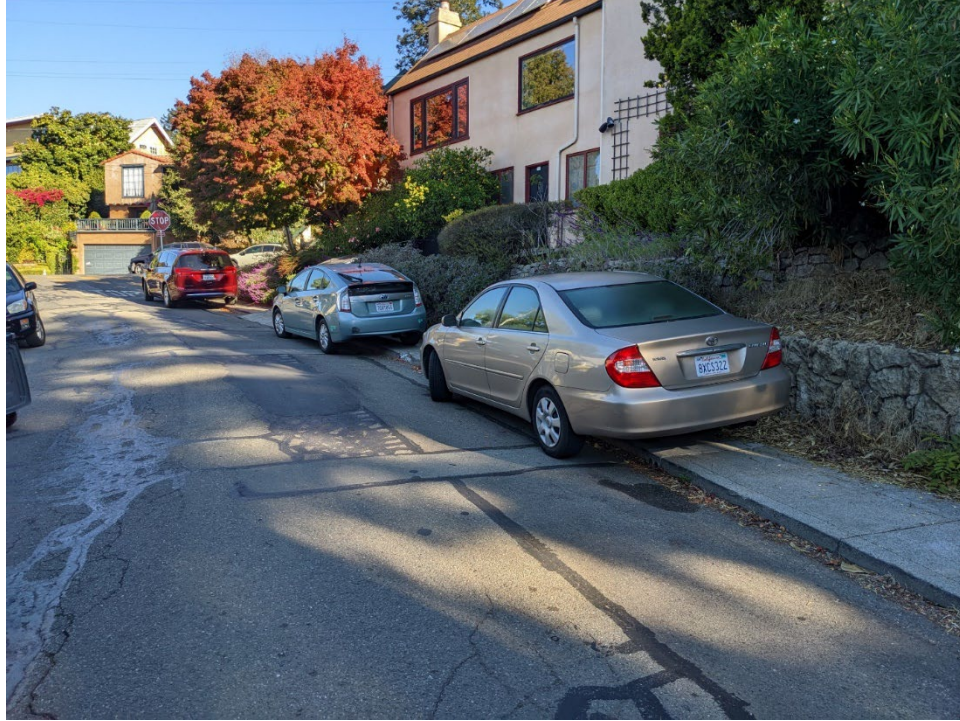
- Speed feedback signs on Marin Ave have since been installed by the City of Berkeley.
- ◆ Drivers parked vehicles partially on the sidewalk blocking pedestrian access.

- While parking in such a manner did provide enough width for through traffic on the road, conversely it blocked sidewalks for children and anyone walking to access the sidewalk, forcing them into the street to travel.

Above: Parked cars blocking sidewalks on Cragmont Ave north of the intersection.

- *Conduct residential outreach to remind residents to not park on the sidewalk. Long term, if efforts to stop sidewalk parking are not successful, study options for balancing residential parking and sidewalk accessibility on Cragmont Ave between Marin Ave and Regal Rd. Options may include time-limited parking restrictions during school arrival and dismissal times.*
- *Upgrade existing transverse crosswalk across the northern approach to a triple-four crosswalk.*
- *Consider installing RRFBs for Marin Ave crossing.*
- *Extend red curb 90 ft on the east side of the southern leg of Cragmont Ave to the intersection approach with Marin Ave (project in-progress by the City of Berkeley).*

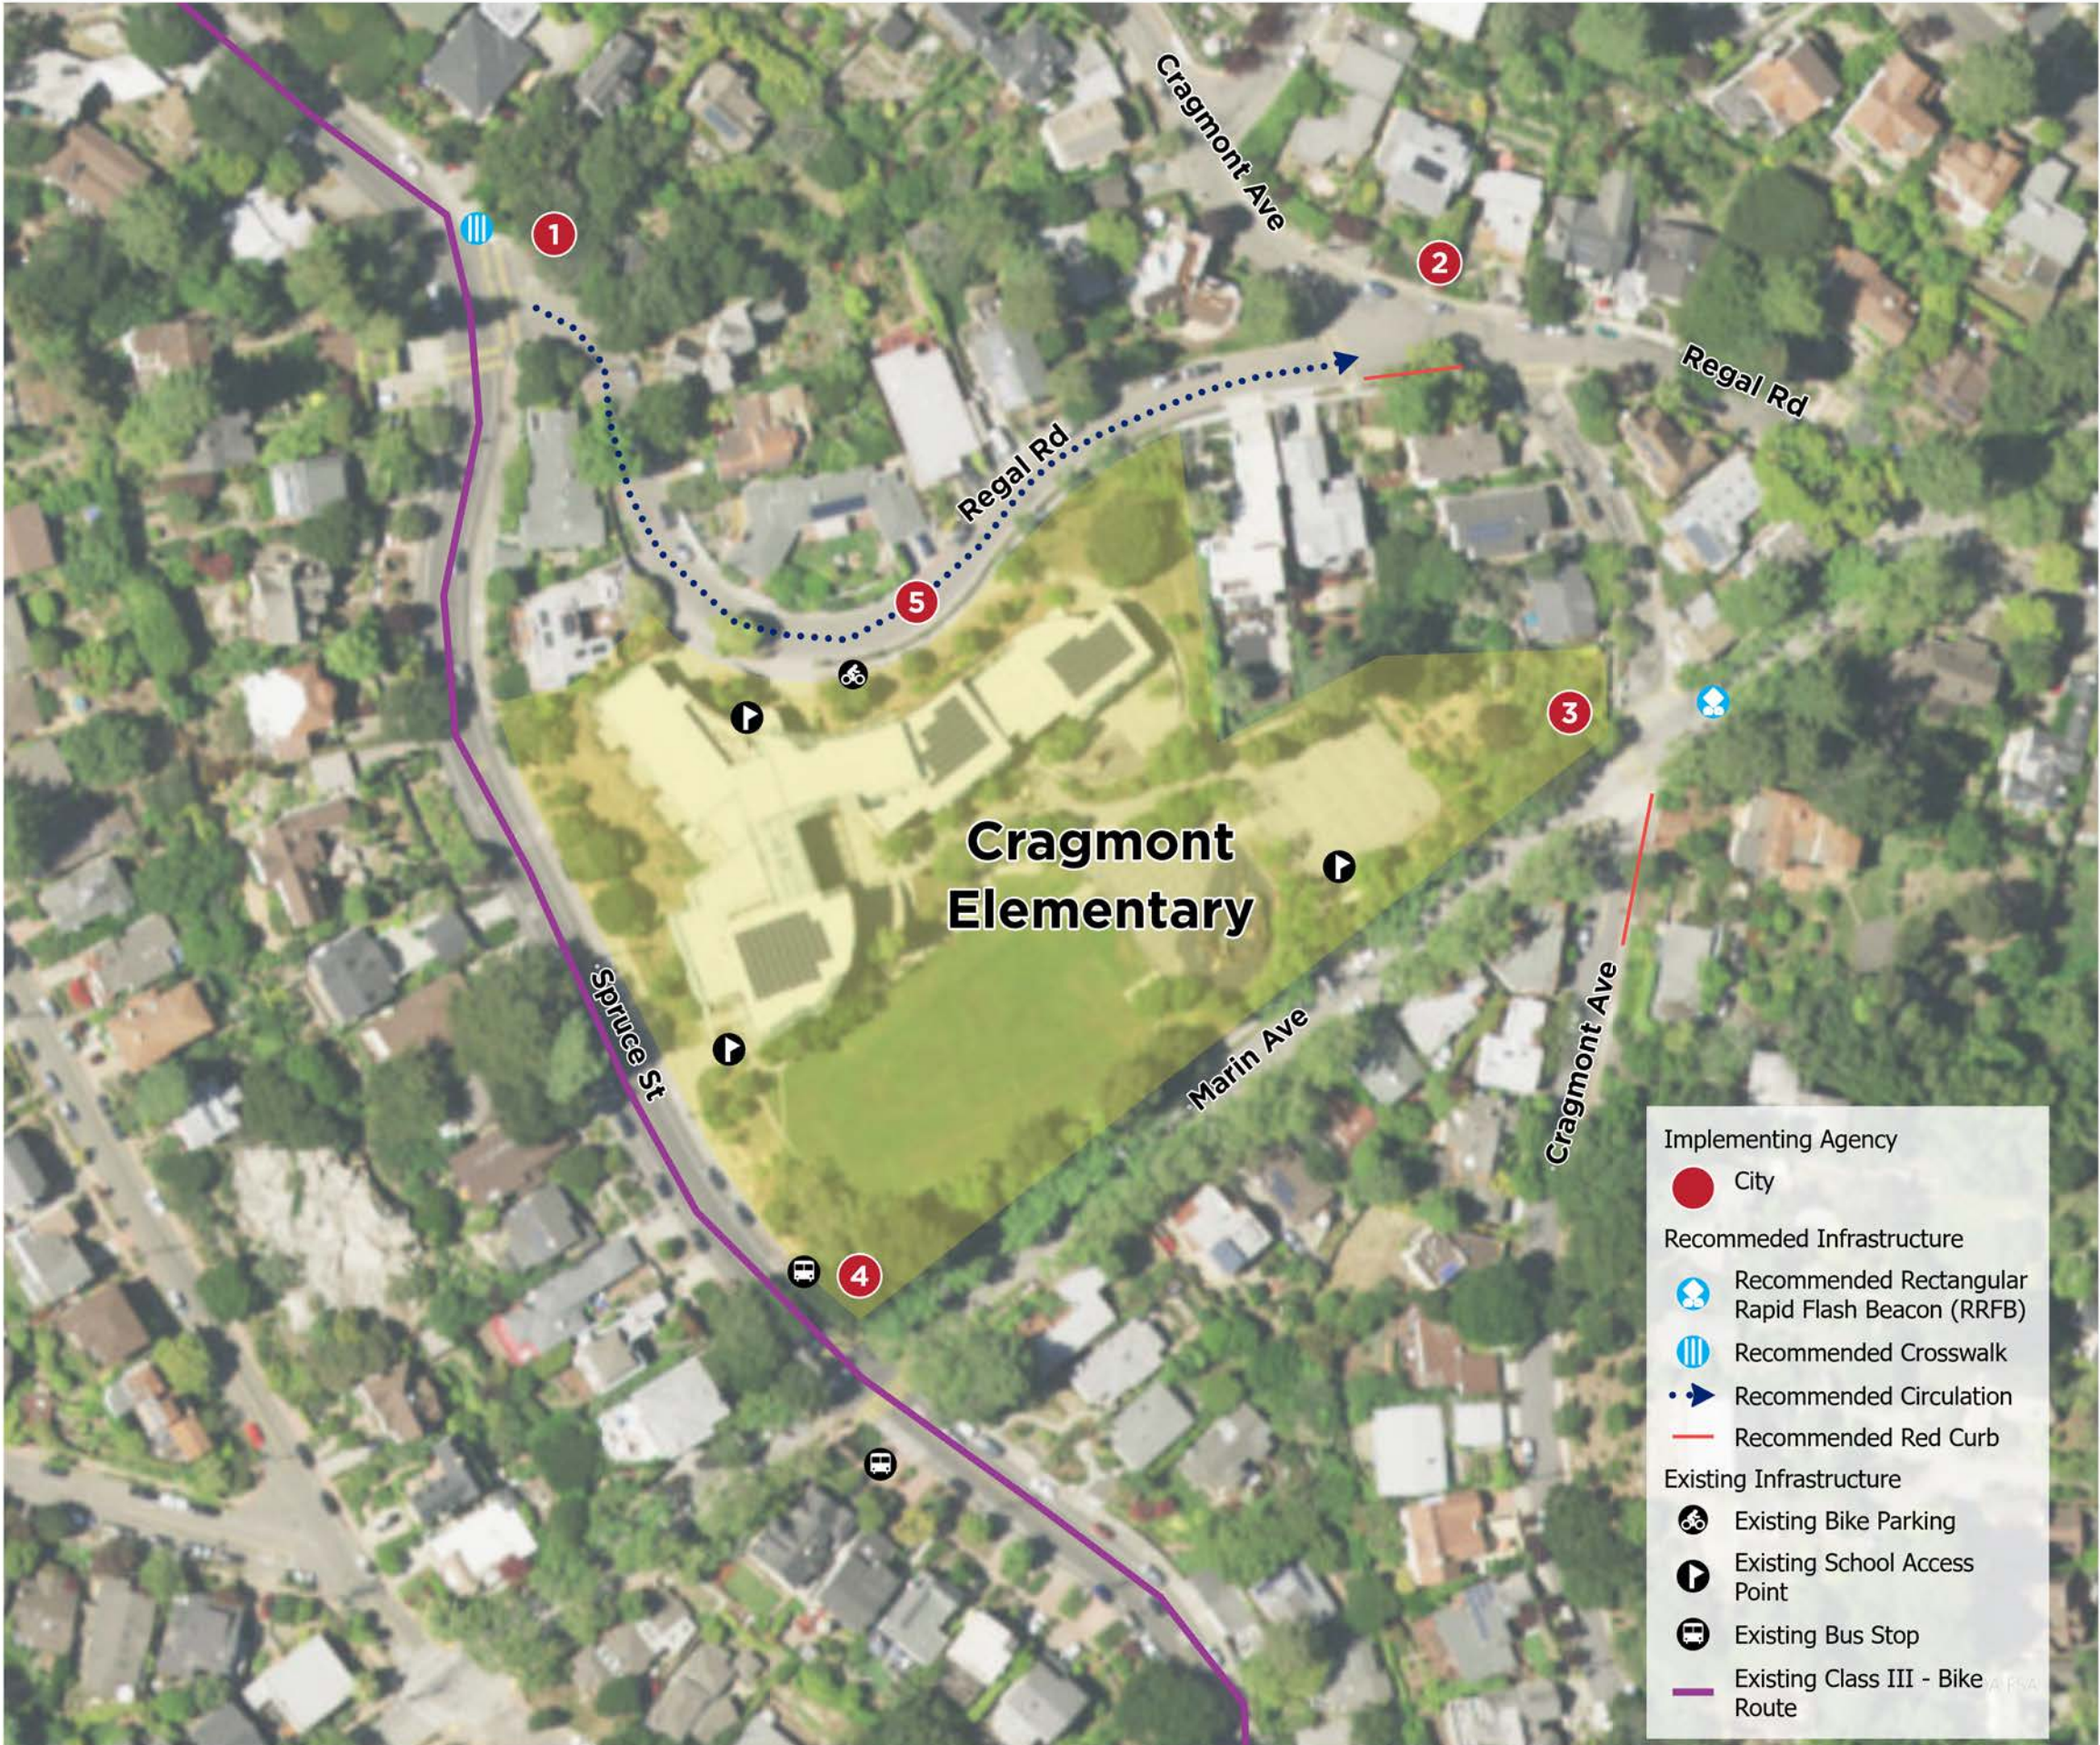
Safe Routes to Schools Improvement Plan
Cragmont Elementary
Berkeley

Improvement Detail

- 1a Study options across Spruce St for crosswalk relocation. Consider sightlines, elevation, and driveway access to determine what is the safest, but also more accessible location. Crosswalk relocation may include the construction of curb ramps, red curb, signage, pavement markings, and street lighting for the new crosswalk. Multiple components of potential crosswalk relocation are subject to traffic engineer review and residential outreach.

- 1b Short term, consider constructing a paint and post curb extension on Regal Rd on the northeast corner of the intersection with Spruce St. Long term, consider upgrading paint and post to concrete curb extension, with attention to concerns about existing stormwater drainage infrastructure, adjacent driveways, and potential crosswalk relocation in the design. Outreach to residents will be necessary due to the potential impacts on residential parking.

- 1c Consider conducting a warrant study for all-way stop control.
- 2a Consider squaring the offset intersection by constructing curb extensions on the southwestern corner where the southern leg of Cragmont Ave intersects with Regal Rd, and on the northeastern side of Regal Rd where it intersects with the northern leg of Cragmont Ave. Further engineering design and residential outreach will be necessary prior to implementation.

- 2b Restripe existing high-visibility crosswalks (northern, western, and southern legs) as triple-fours, and add stop bars at all legs (requires verification of sight lines by the city traffic engineer).

- 2c Extend red curb 35 ft on the south side of Regal Rd, from Cragmont Ave to the crosswalk west of Cragmont Ave (requires sight line verifications from the city traffic engineer). Residential outreach will also be necessary prior to implementation.

- 3a Conduct residential outreach to remind residents to not park on the sidewalk. Long term, if efforts to stop sidewalk parking are not successful, study options for balancing residential parking and sidewalk accessibility on Cragmont Ave between Marin Ave and Regal Rd. Options may include time-limited parking restrictions during school arrival and dismissal times.

- 3b Upgrade existing transverse crosswalk across the northern approach to a triple-four crosswalk.
- 3c Consider installing RRFBs for Marin Ave crossing.

- 3d Extend red curb 90 ft on the east side of the southern leg of Cragmont Ave to the intersection approach with Marin Ave (project in-progress by the City of Berkeley).

- 4a Construct curb ramp to make southwest corner ADA accessible (will require field verification from city traffic engineer prior to implementation).
- 4b Long term: Construct 4 ft of sidewalk to fill missing gap at the southwest corner.

- 5a Restripe red curb paint on southern curb of Regal Rd between Cragmont Ave and Spruce St.
- 5b Conduct a circulation traffic engineering study for Regal Rd between Spruce St and Cragmont Ave in consideration for eastbound one-way traffic flow with access from Spruce St. If the recommendation does not proceed, consider adding "No Stopping" signs along the southern curb.
