STROBRIDGE ELEMENTARY SCHOOL

ALAMEDA COUNTY UNINCORPORATED AREAS SAFE ROUTES TO SCHOOL PLAN

PROJECT OVERVIEW

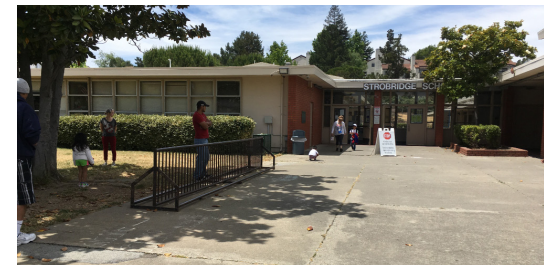
**Crossing Guard** Grove Way/Bedford Drive intersection
