School Safety Assessment Technical Memorandum

Jefferson Elementary School

San Leandro Unified School District

April 2018

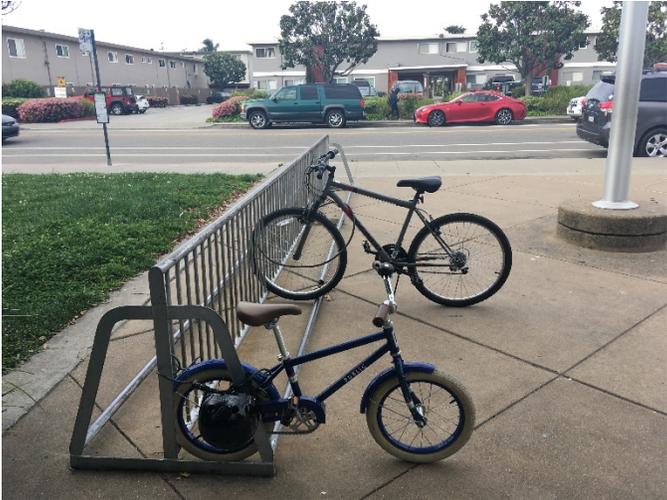
<p>Does the school have bike racks? What is the capacity? Is it secure bike parking?</p>	<p>There are two bike racks located on the school’s campus. One rack is located in the front plaza area of the school (unsecure) and the second is within the locked campus near the Lark Street back gate. Both racks are “schoolyard” style racks.</p> <p>There is parking capacity for about 30-40 bikes. School staff reported that less than 5 students and staff regularly bike to school.</p>
<p>How do school and transit buses interact with the school?</p>	<p>AC Transit lines 40 and 89 run along Bancroft Avenue, with a stop in each direction located in front of the school. School staff reported that no (or very few) of their students utilize public transit.</p> <p>There are school buses that serve Jefferson Elementary. Much of the bus pick-up and drop-off occurs in the parking lot of Toyon Park (next door).</p>

The bike racks located in the front of the school along Bancroft Avenue

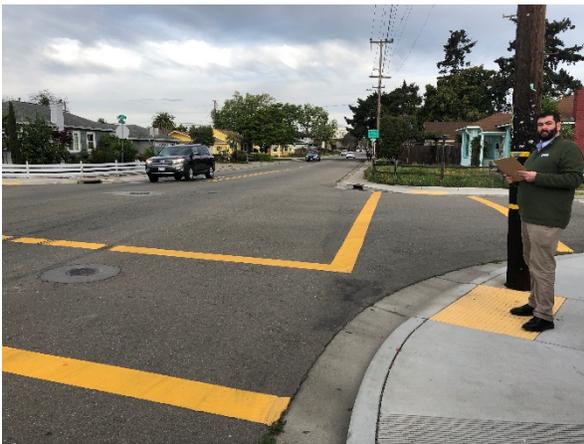
- ◆ This is an all-way stop controlled intersection. Three of the four approaches are marked with transverse crosswalks. The north approach does not have a marked crossing.

- ◆ SSA participants reported that cars regularly enter the intersection before pedestrians have completely cleared the crosswalk, and this was also observed during the assessment.

- ◆ Participants observed multiple (northbound) cars stopping in the crosswalk (southern approach), not in advance of it; there is not currently an advance stop line at this approach.

Left: The Bancroft Avenue/142nd Avenue intersection, looking north with a Jefferson parent conducting his observations

- 1 Bancroft Avenue/142nd Avenue**
 - Convert three existing transverse crosswalks to high visibility crosswalks with advance stop markings
 - Stripe the missing crosswalk at the northwest approach as a high visibility crosswalk with advance stop marking

- Install/refresh red curb near all corners
- 2 Bancroft Avenue**
 - Install curb extensions on both sides of the mid-block crossing across Bancroft. Refresh high visibility crosswalk

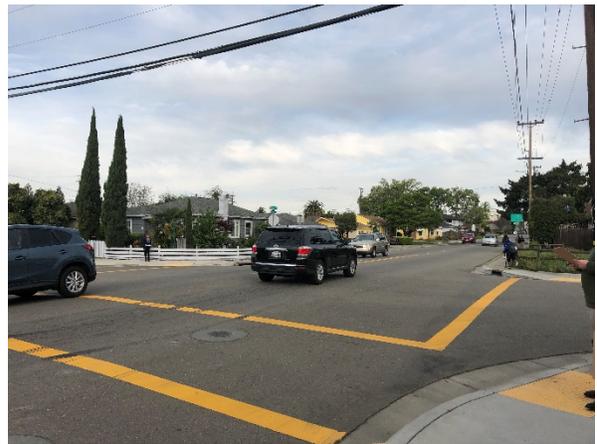
Right: The intersection from the same perspective, looking slightly more west

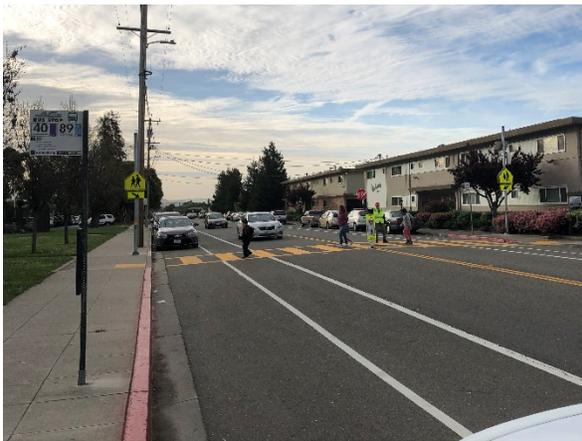
- ◆ Midblock crossings (outside of a crosswalk) across Bancroft Avenue were observed throughout the school's frontage.
- ◆ There is a mid-block crossing in front of the school that is staffed by a crossing guard.

Left: The crossing guard assisting students across Bancroft Avenue at the mid-block crossing. One of AC Transit bus stops is located near this crossing.

- Install yield pavement markings in advance of this crosswalk
 - Upgrade the existing flashing signs to RRFBs
 - Install/refresh red curb near all crosswalks and driveways

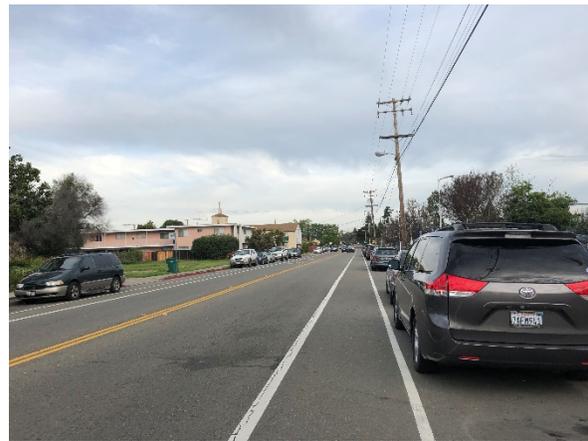
Right: Bancroft Avenue, looking north from near the entry driveway.

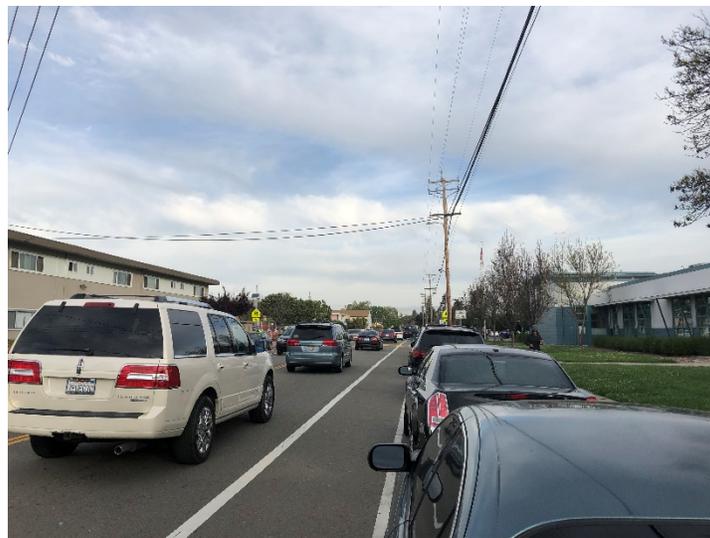
vehicle queue backs up onto Bancroft Avenue in both directions from the entrance driveway from vehicles trying to enter the loop.

Bottom: Cars backed up along Bancroft Avenue waiting to enter the drop-off loop, looking north.

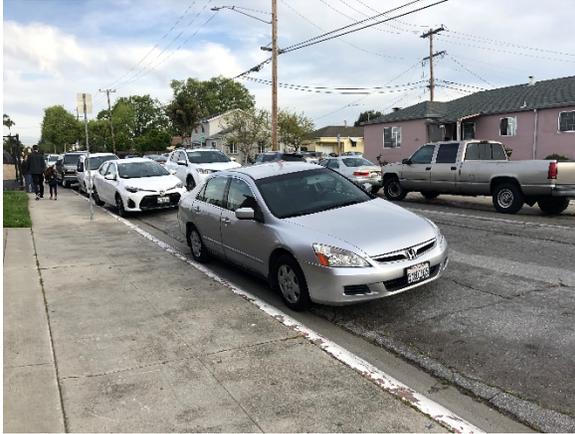
- This driveway was seen being used as a drop-off area by some parents.
Additionally, some families will walk along the driveway to access the school.
- ◆ SSA participants observed cars double parking and pulling to the opposite curb while dropping off students along Lark Street.

Top left: Cars parked along Lark Street, in front of the school

- Install speed feedback signs along Bancroft Avenue
 - Install bike lane conflict markings at major driveways along Bancroft Avenue
- 3 Lark Street**
 - Install/refresh red curb near all crosswalks and driveways

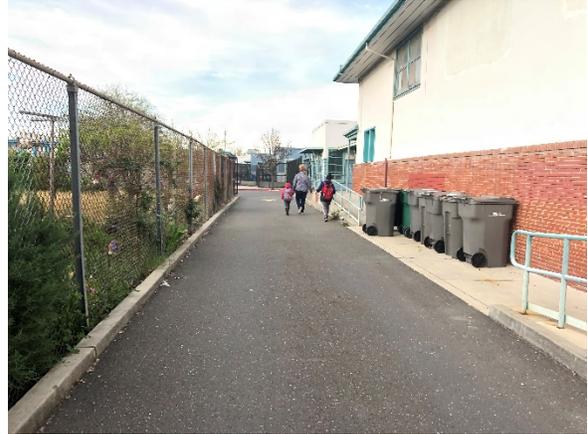
- ◆ An access driveway on Lark Street leads to both Jefferson School staff parking and the Toyon Park parking lot. This is a very narrow driveway, with no pedestrian considerations.

Top right: A family walking in the school driveway accessible from Lark Street

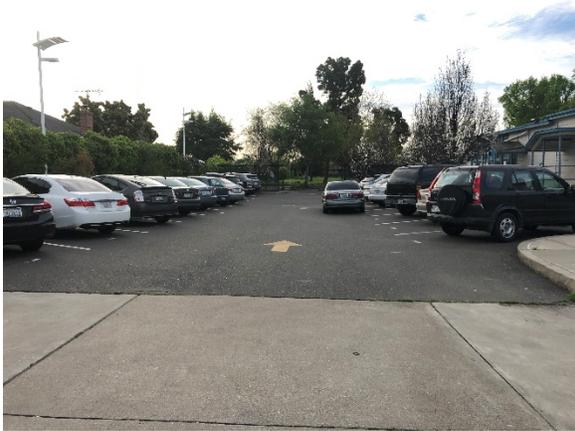
Bottom left: The back entrance to the staff parking with a car parked to drop-off a student

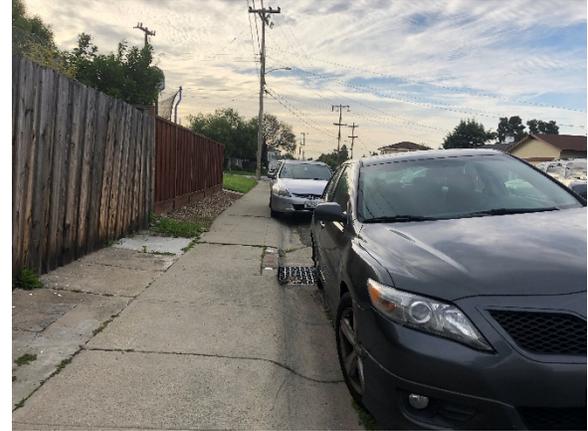
- ◆ SSA participants also observed students and families crossing Lark Street at the unmarked eastern crossing of Lark Street/Russ Avenue.
- ◆ There are rolled curbs along Lark Street. Some cars were parked on the sidewalk, limiting space where pedestrians could walk.

Bottom right: Cars parked along Lark Street. These cars are parked at various locations along the rolled curb/sidewalk

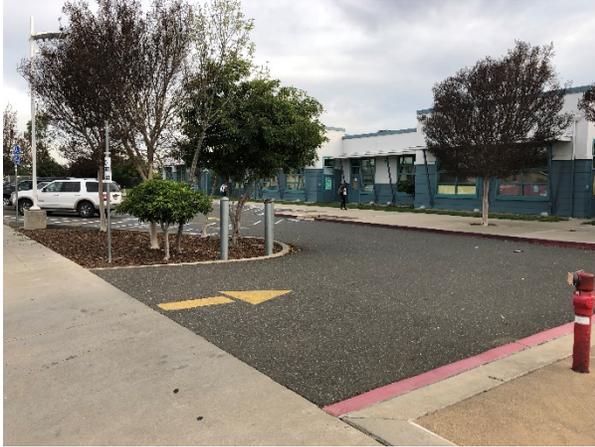
- ◆ SSA participants observed cars pulling into both driveways of the drop-off loop (one-way circulation: one driveway in and one driveway out), dropping off students, and then backing out of the driveway. This occurred at both the entry and exit driveways. SSA participants noted that this behavior is more common during afternoon pick up.
- ◆ School staff noted that some parents will misuse the disabled person parking stalls.
- ◆ Cars do not pull forward in the drop-off loop, despite instruction from school staff to do so.

Left: The entrance the drop-off loop

- Install a high visibility crosswalk within the parking lot to provide a dedicated space for pedestrian crossings
- 5 Drop-off Loop**
 - Place cones along short segments of the double yellow on Bancroft Avenue to discourage left turns into and out of the drop-off loop

- Install signage at the exit of the drop-off loop to prohibit left turns out of the driveway

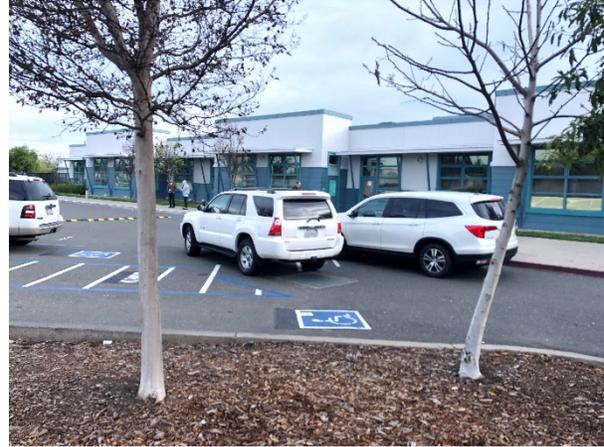
Right: A car going around an idle car that did not pull forward

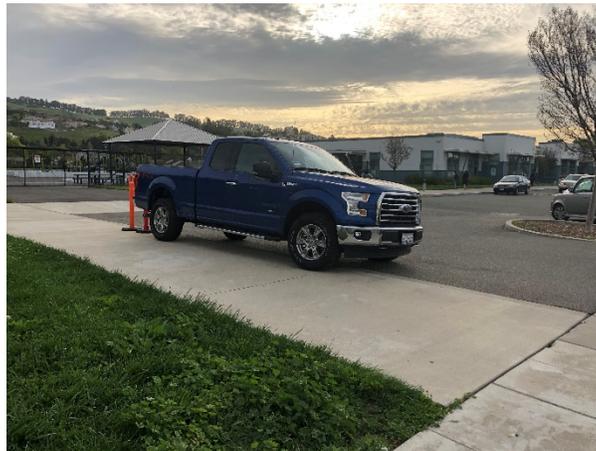
Bottom: A truck that backed-into the exit driveway and parked on the sidewalk close to the exit

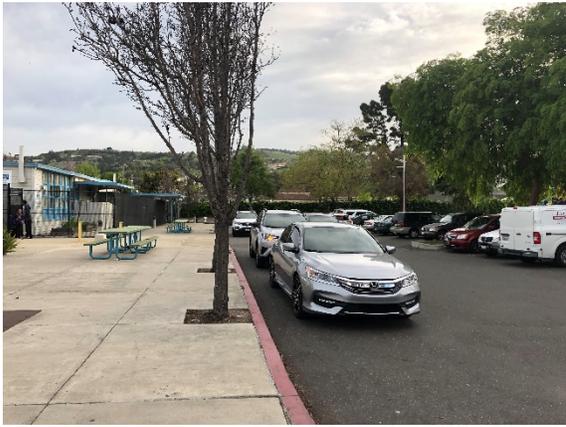
- ◆ Jefferson Elementary buses for special needs students use the curb space immediately adjacent to the school in the parking lot as their loading area.

Left: The curb frontage next to the school in Toyon Park's parking lot

- Install School Assembly B signs in advance of all crossings at uncontrolled approaches
- 4 Tonya Park Parking Lot**
 - Replace the existing red curb along the school's frontage with white curb for student loading and unloading

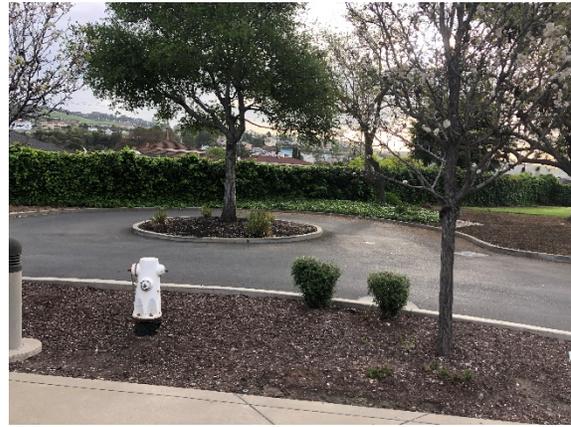
- ◆ During pick-up and drop-off times, this parking lot is filled with parents vehicles both parking and loading/unloading.
 - In this parking lot, some parents will park their car and walk their child into the school's side entrance, other parents will perform a U-turn in the parking lot to pull along the curb to drop off their child, and others will use the small turnaround area to get to the curb.

Right: Towards the back of Toyon Park's parking lot, there is a small turn around area for cars

- Install signage (Passenger Loading R25D) and markings to better indicate the flow of the parking lot/drop-off area
 - Install a "STOP" sign and "STOP" pavement markings at the northern park driveway

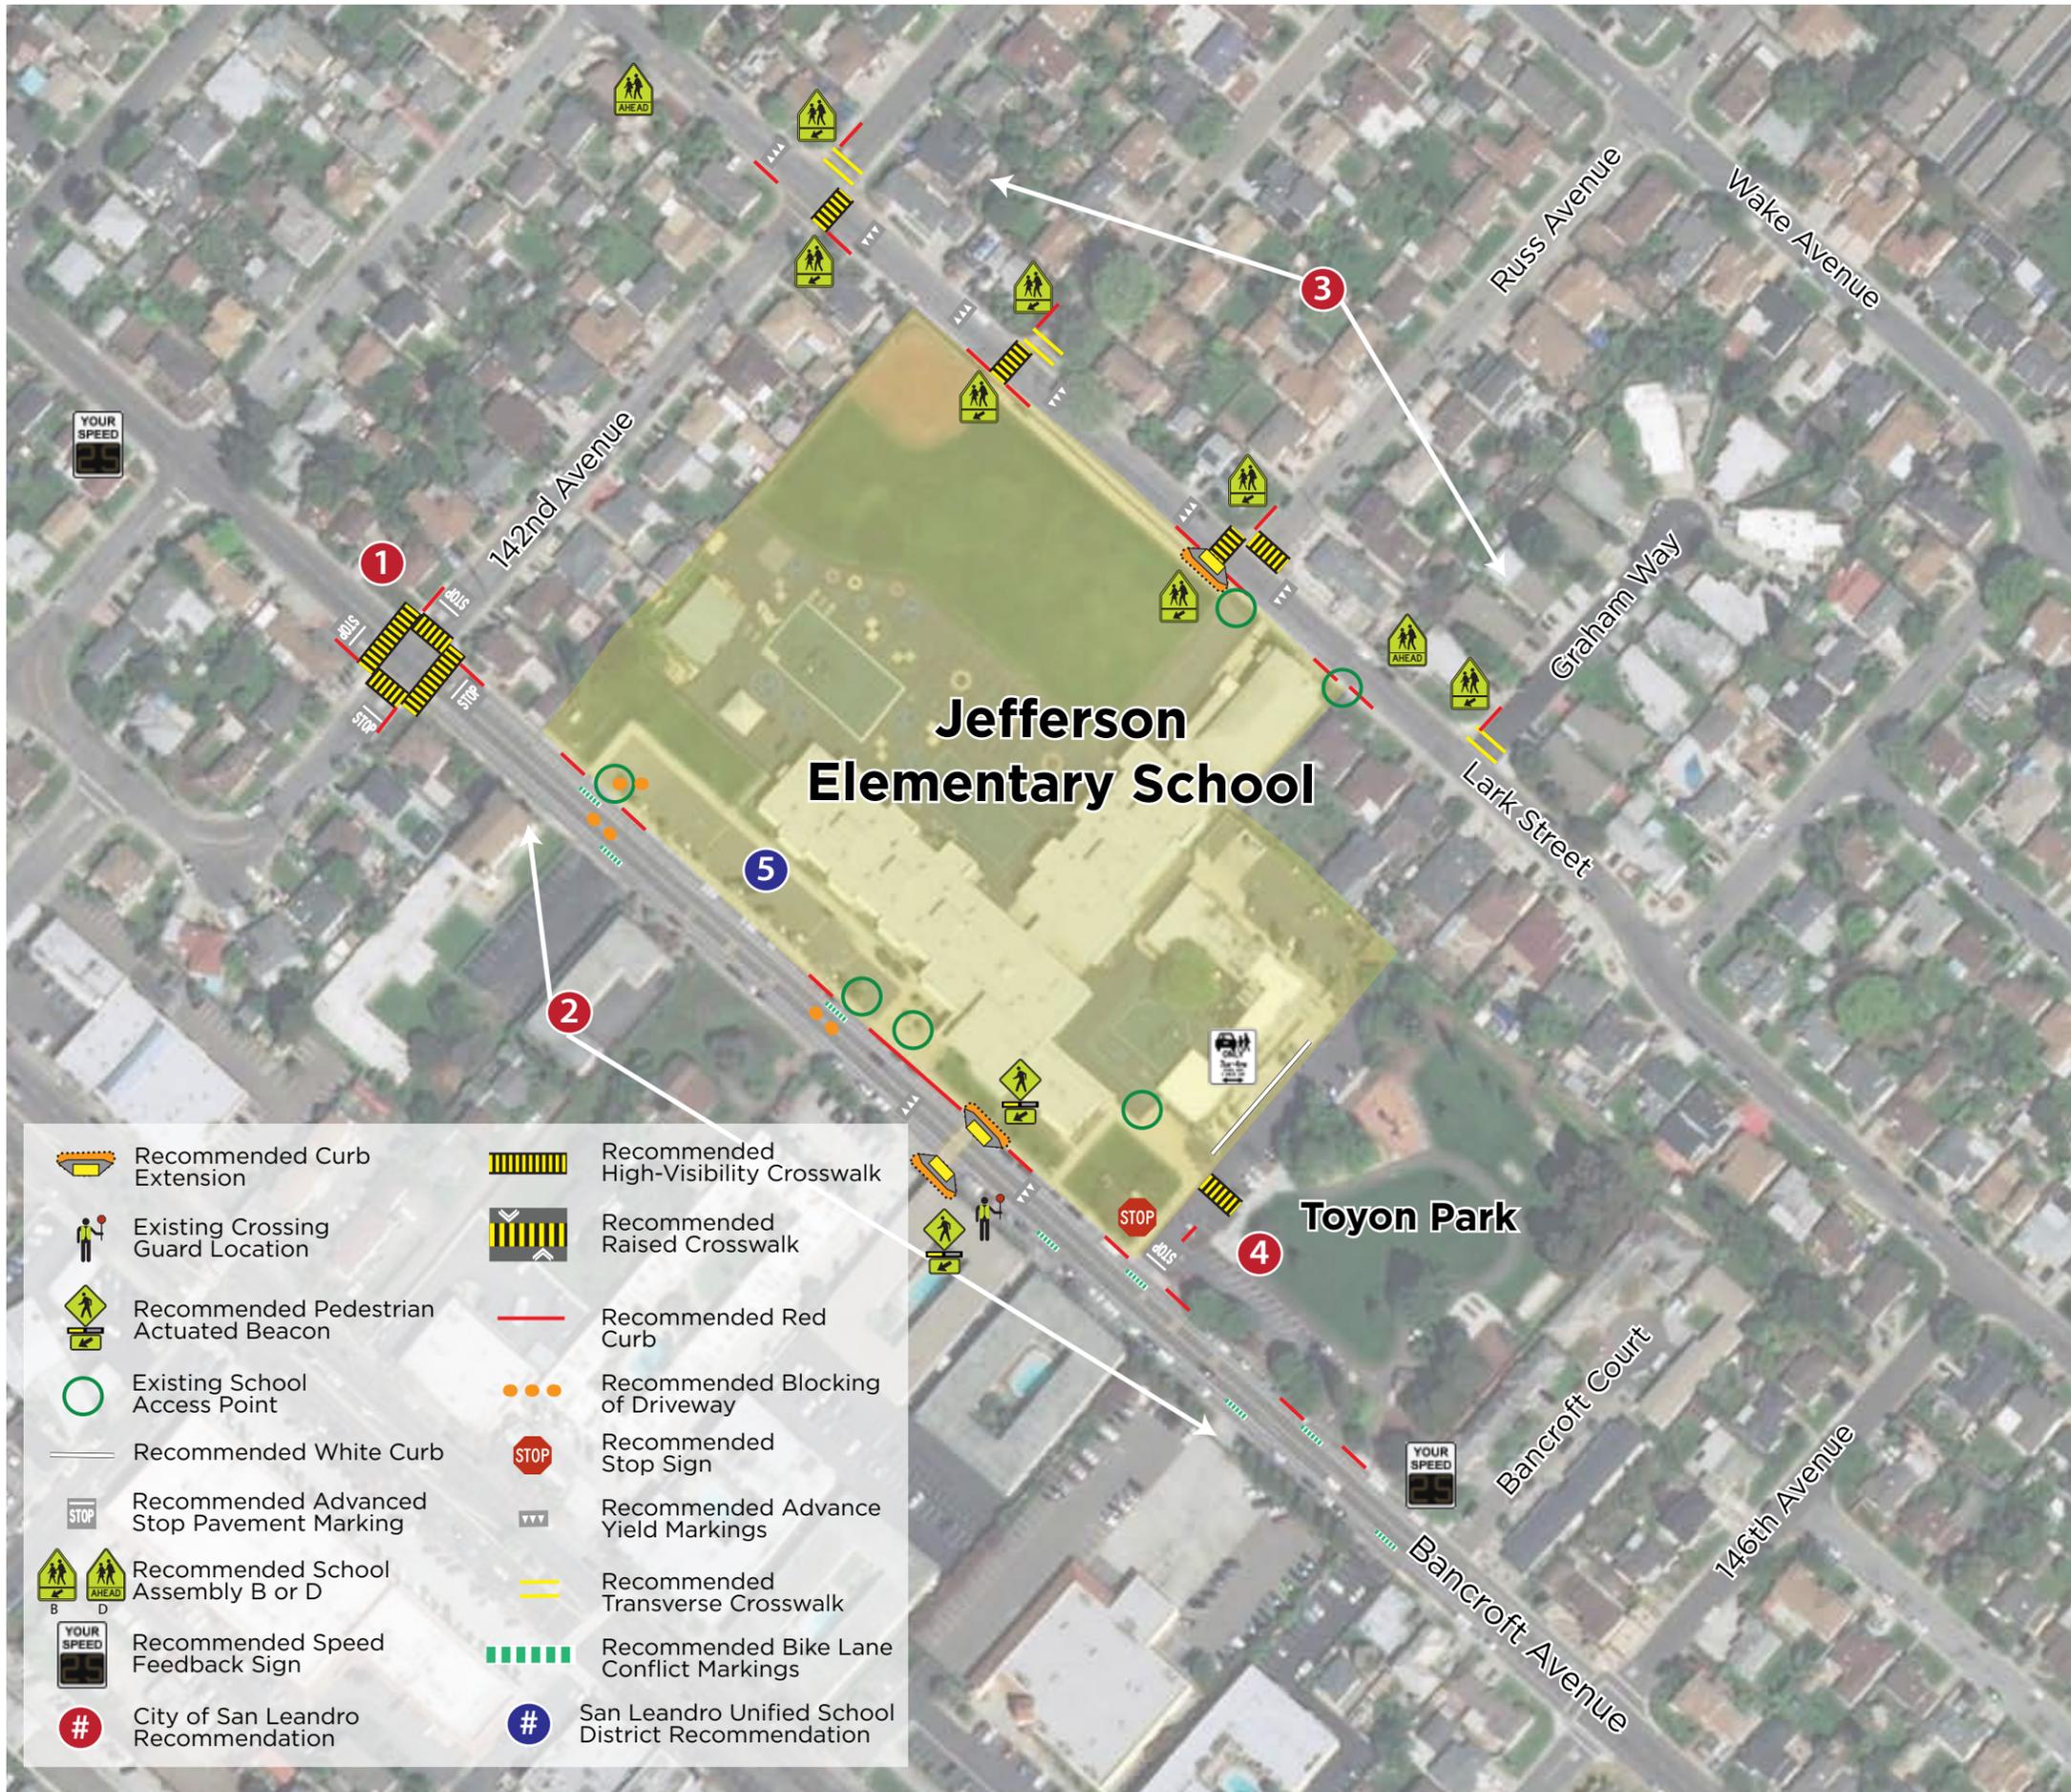
Safe Routes to Schools Improvement Plan

- Convert existing two transverse crosswalks (at Russ/Lark) to high visibility crosswalks
 - At the Russ intersection, build a curb extension on the school side of the crosswalk

- Install advance yield markings before the Lark Street crossings
 - Update the "School Zone" sign near Lark/142nd to current standards or replace with School Assembly D sign
