Hearst Elementary Safe Routes to School Improvement Plan

Site Assessment held on November 17, 2014

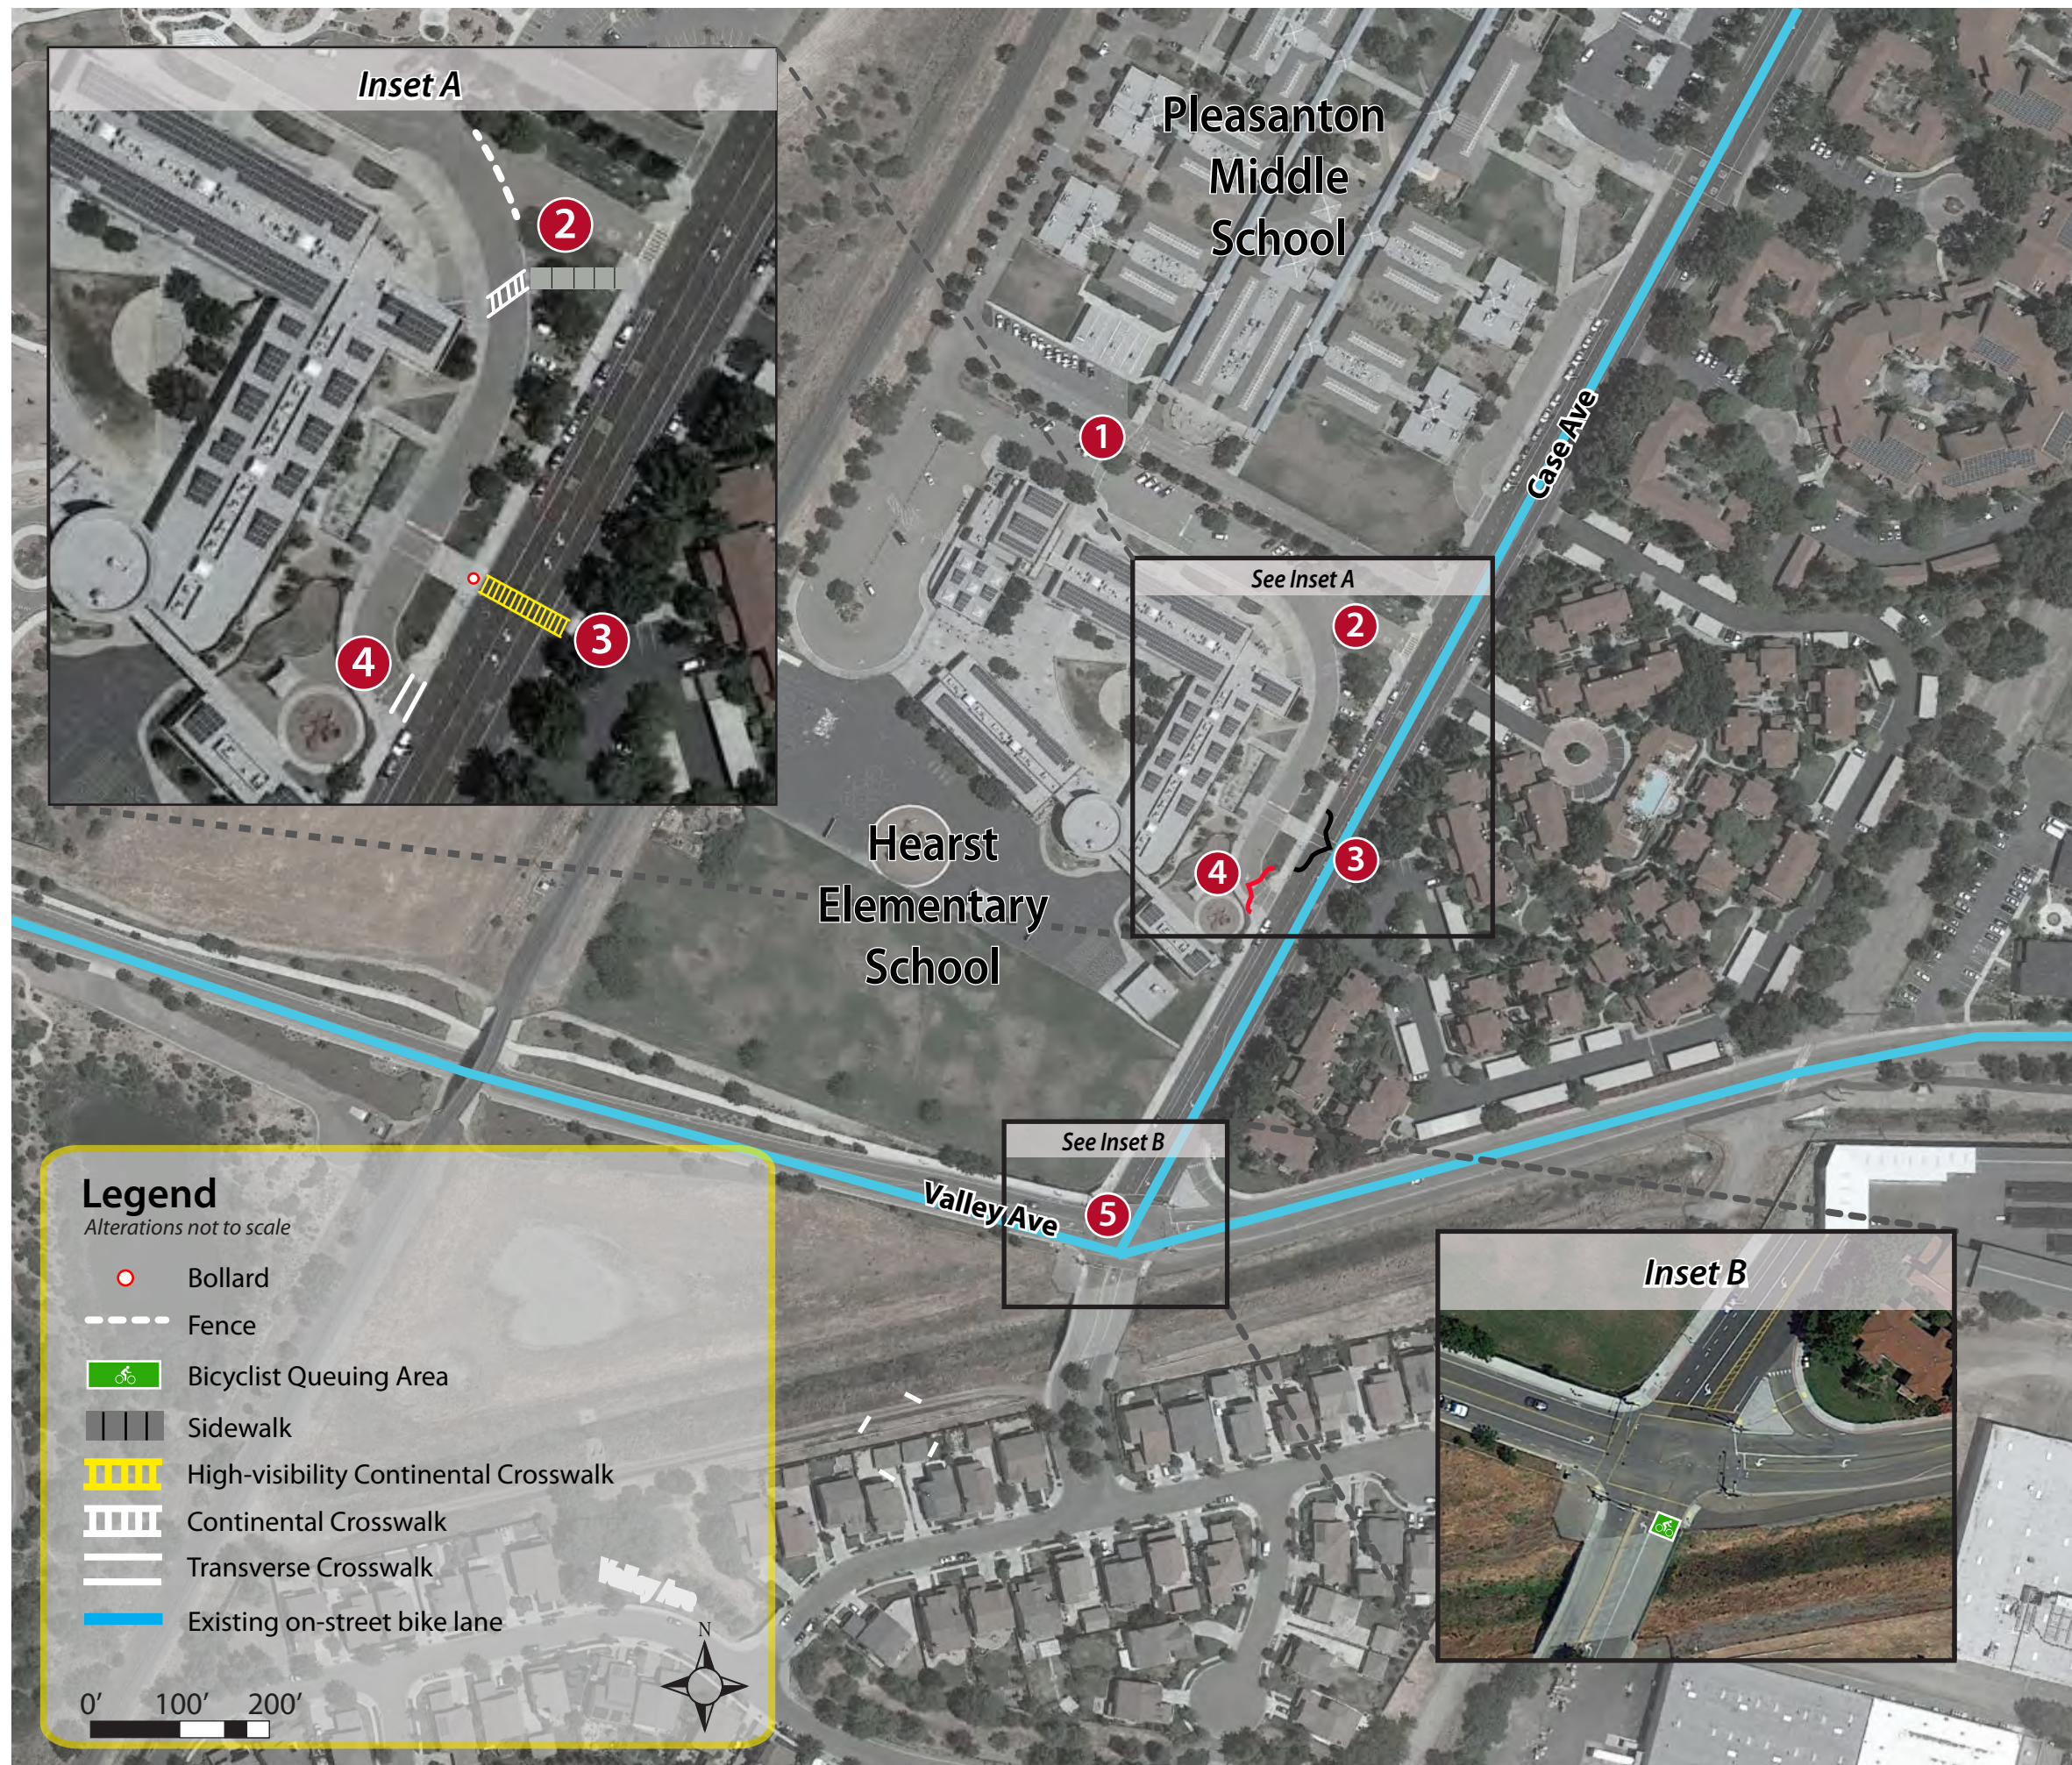
- 1 Hearst Elementary Parking Lot Crosswalk**
 - School District is reviewing for improvements
- 2 Southeast School Entrance**
 - *Short term* - Consider installing fence at corner to reinforce usage of school entrance further to the south. Refresh disabled parking access striping.
 - *Long term* - Consider installing path connecting disabled parking access striping and sidewalk to formalize crosswalk.
- 3 Case Avenue midblock crosswalk**
 - Install single bollard at path to school entrance
 - Consider relocating speed bump before crosswalk
 - Restripe yellow transverse crosswalk as yellow high visibility crosswalk
- 4 Parking Lot Exit**
 - Refresh crosswalk striping
- 5 Valley Avenue at Case Avenue**
 - Consider Lead Pedestrian Interval (LPI) signal phasing
 - Construct queuing area for bicyclists exiting the path at the southeast corner

- Install truncated domes at all curb ramps
